*The Relationship Between the Inside and Outside Environments of the
Shippensburg University Rife Alumni House: A Comprehensive Energy Analysis*

Michael D. Griesemer

GEO 549

Shippensburg University

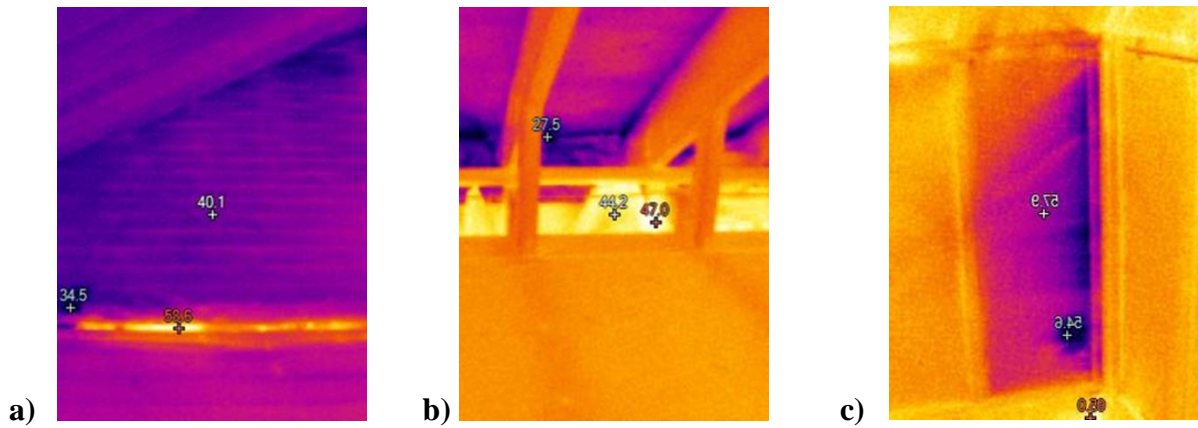
Figure 14: Examples of attic air sealing and insulation flaws (Michael D. Griesemer 2013).

The thermal images in Figure 14 provide a good indication of the present stack effect while displaying evidence of heat exfiltration through the buildings framework. Similarly, in Figure 15, it can be seen that cooler air is infiltrating at the lowest level of the building envelope, causing heat to escape through the upper levels.

- 1) Insulating and air sealing the third floor attic space
- 2) Air sealing the basement rim and band in order to isolate air infiltration
- 3) Insulating and air sealing accessible basement rim and band
- 4) Fixing or replacing window and door seals and/or sills
- 5) Replacing single pane wooden frame windows if it is found to be cost-effective

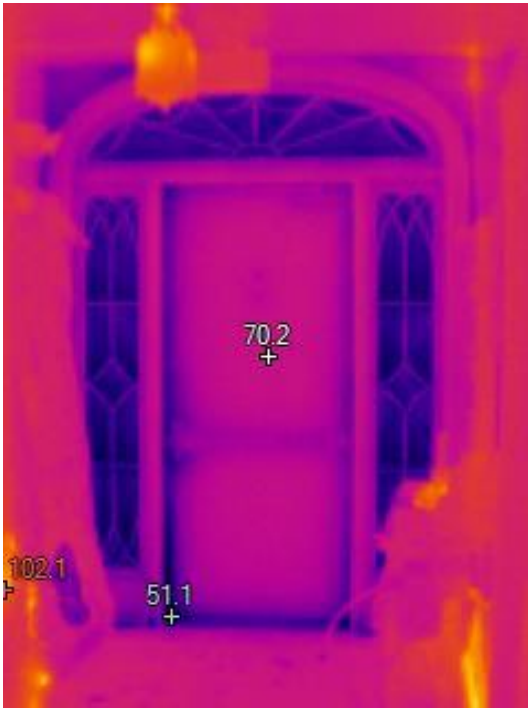
First Floor Front Door
12/9/2013 5:21:23 PM

Single pane side/top lights. One inch insulated steel.

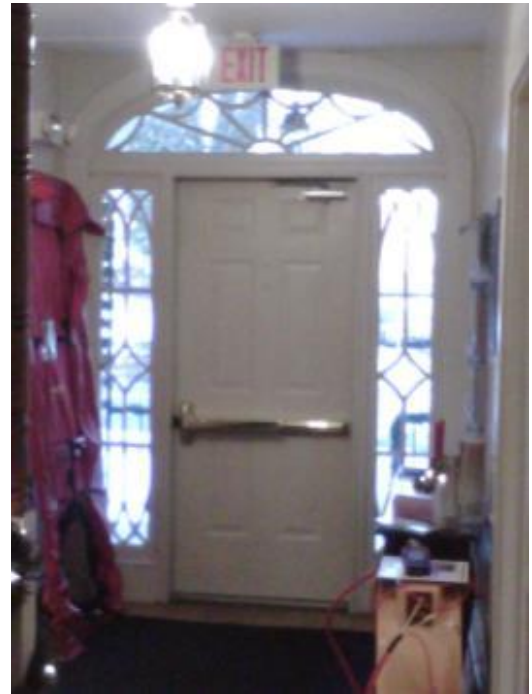
First Floor Front Door
12/9/2013 5:21:45 PM

Evidence of air movement
through handed side of door.

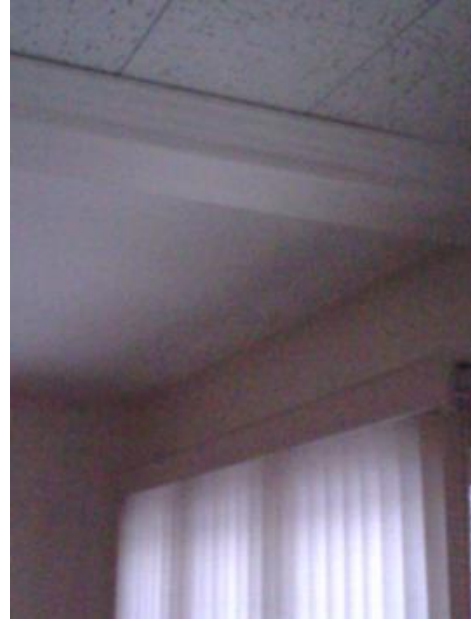
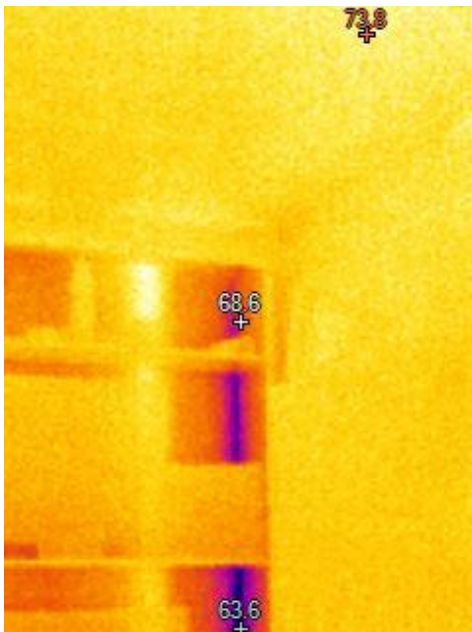
First Floor Meeting Room
12/9/2013 5:32:00 PM

Figure shows evidence of top place air movement due to improper sealing.

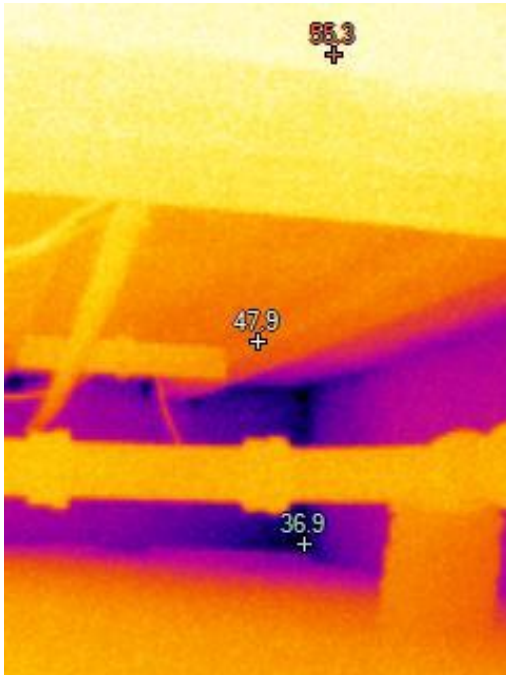
Left-Rear Elevation Basement Crawlspace
12/9/2013 5:41:02 PM

Air infiltration through the basement rim and band.

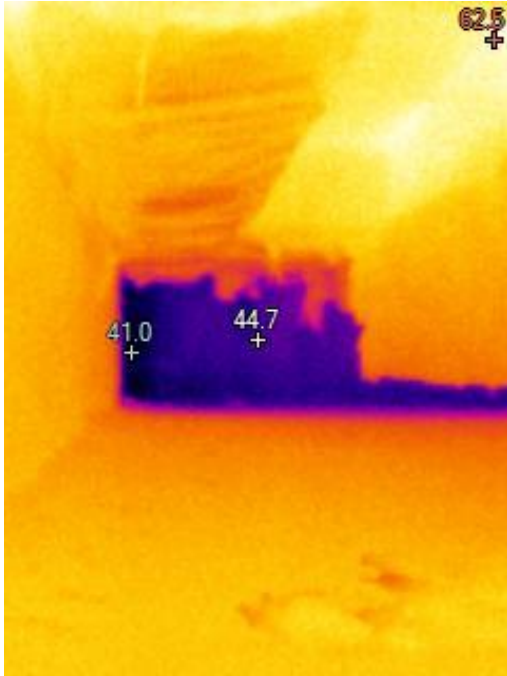
Left-Elevation Basement Crawlspace
12/9/2013 5:41:56 PM

Air infiltration through the basement rim and band.

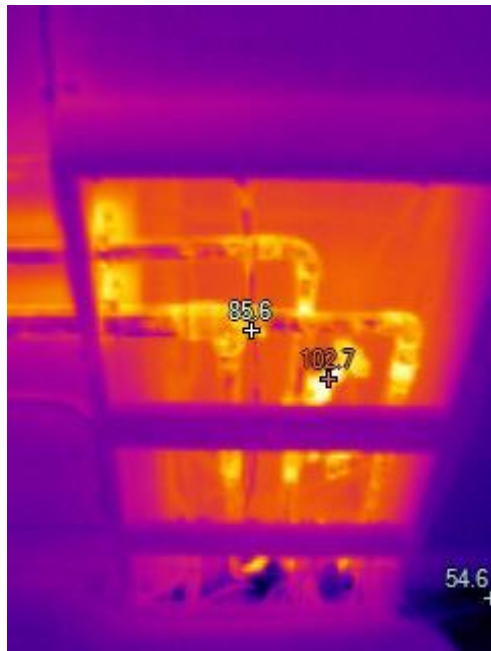
Basement- Water Pipes in Ceiling
12/9/2013 5:42:48 PM

Lack of insulation.

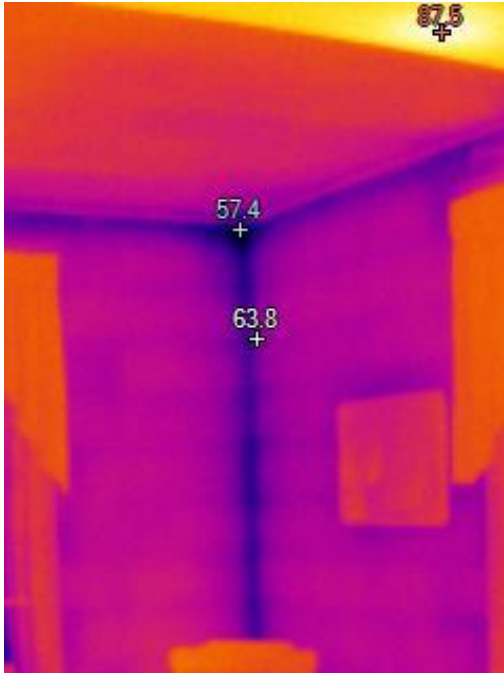
Second Floor Front Elevation
12/9/2013 5:48:00 PM

Air movement through wall seam.

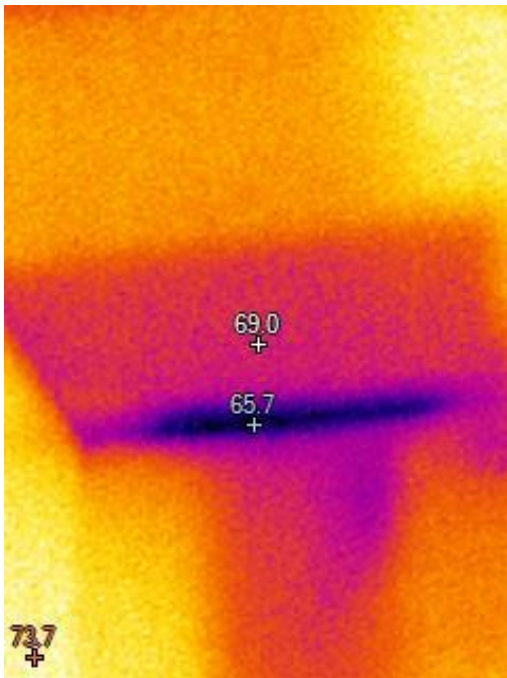
Second Floor Office; Right Elevation
12/9/2013 5:49:02 PM

Top plate air movement.

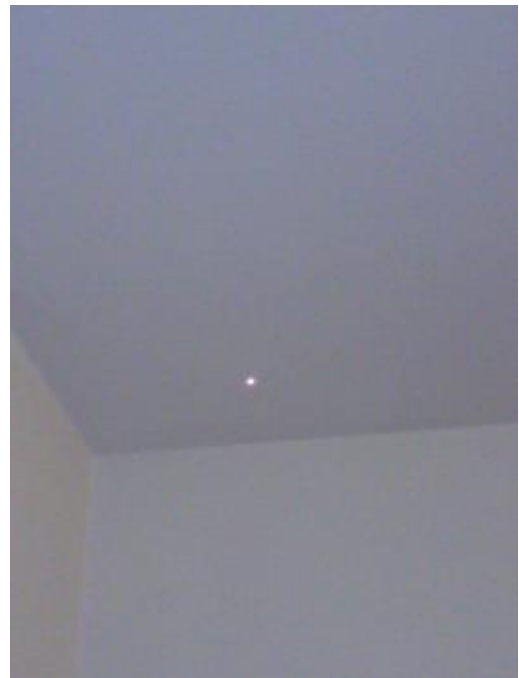
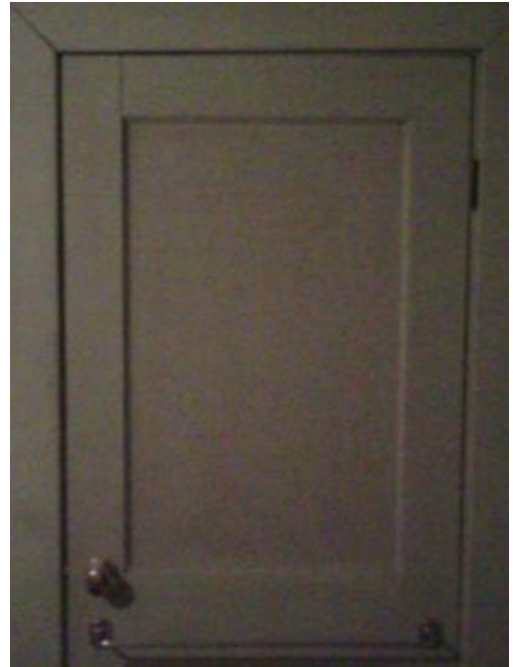
Attic Door
12/9/2013 6:09:23 PM

Lack of insulation.

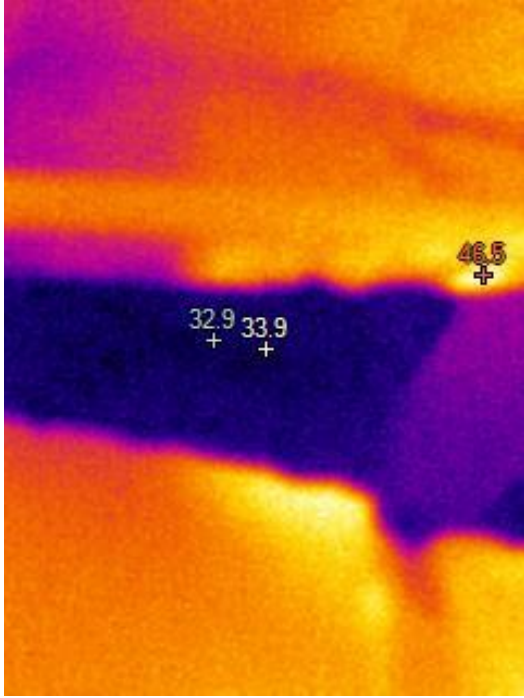
Basement Ceiling
12/9/2013 6:42:18 PM

Top plate air movement.

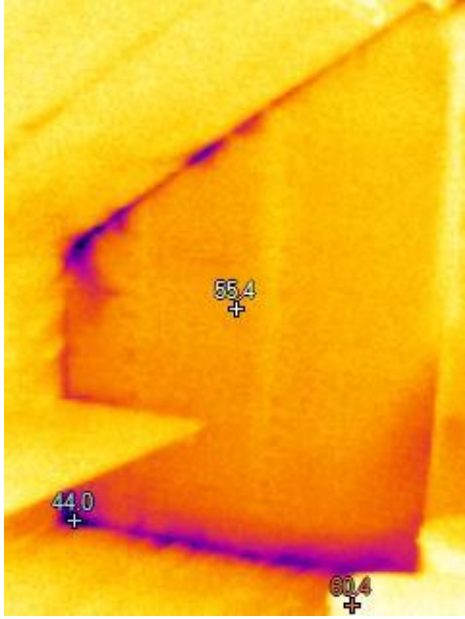
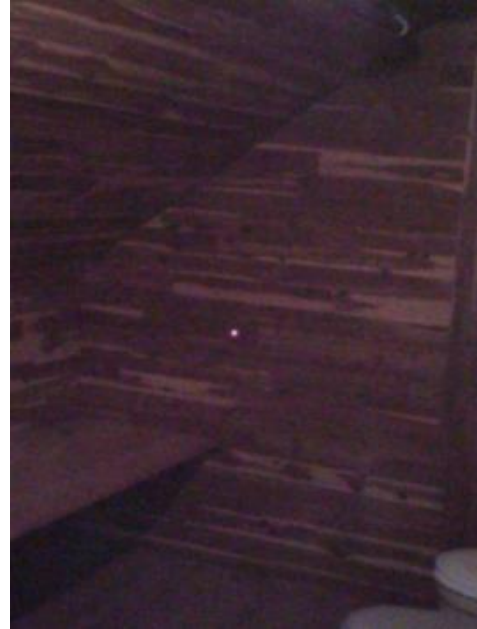
Third Floor Attic Cedar Room
12/9/2013 6:56:50 PM

Air infiltration through the perimeter.

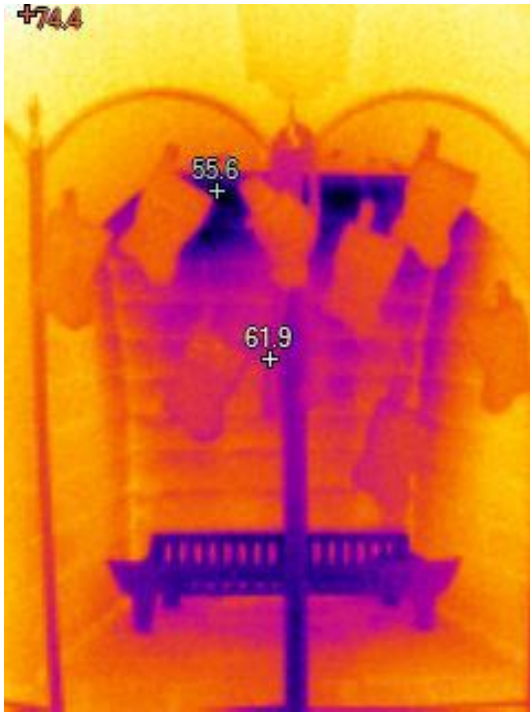
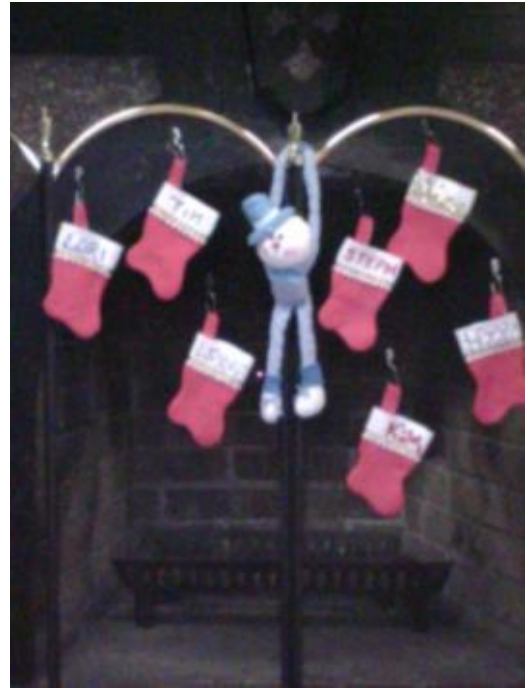
First Floor Fire Place
12/9/2013 7:01:41 PM

Presence of air infiltration through the top of the flu.
