**ENGINEERING STUDY**  
of  
**NATURAL GAS DISTRIBUTION SYSTEM  
IMPROVEMENTS**

at  
**SHIPPENSBURG UNIVERSITY**  
**Shippensburg, Pennsylvania**

**Natural Gas Distribution System  
Engineering Study**

**Heath Consultants, Inc. - Gas Leak Survey**

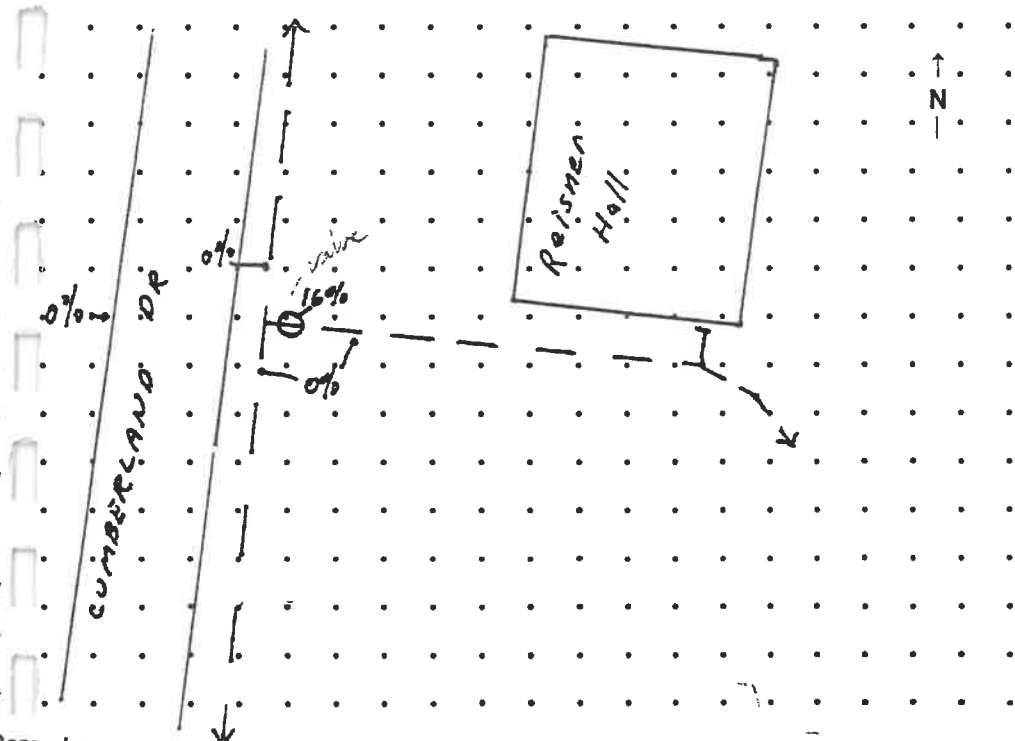
LEAK INDICATION APPEARS TO BE AT:	
Main	<input type="checkbox"/>
Service	<input type="checkbox"/>
Service Tap	<input type="checkbox"/>
Main At Tie In	<input type="checkbox"/>
Drip	<input type="checkbox"/>
Meter	<input type="checkbox"/>
Curb Valve	<input type="checkbox"/>
Main Valve	<input checked="" type="checkbox"/>
Other	<input type="checkbox"/>

Remarks  
Leak appears to be in valve. 16% gas read

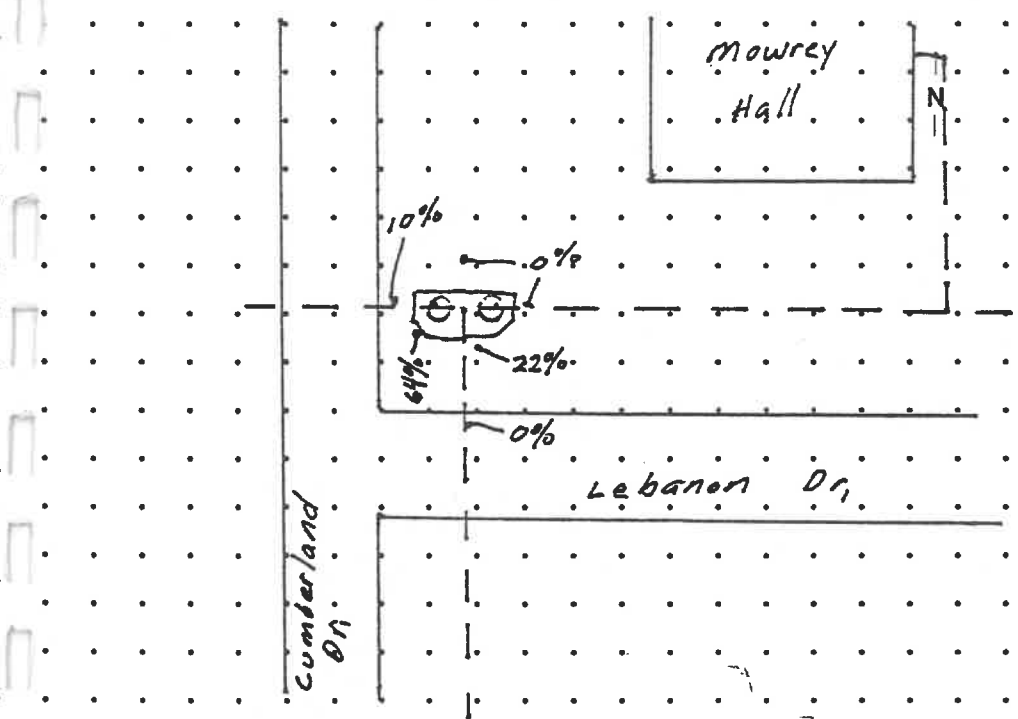
LEAK INDICATION APPEARS TO BE AT:	
Main	<input checked="" type="checkbox"/>
Service	<input type="checkbox"/>
Service Tap	<input type="checkbox"/>
Main At Tie In	<input type="checkbox"/>
Drip	<input type="checkbox"/>
Meter	<input type="checkbox"/>
Curb Valve	<input type="checkbox"/>
Main Valve	<input type="checkbox"/>
Other	<input type="checkbox"/>

Remarks  
Leak appears to be under concrete pad. 0% gas in both valves. 64% gas @ edge

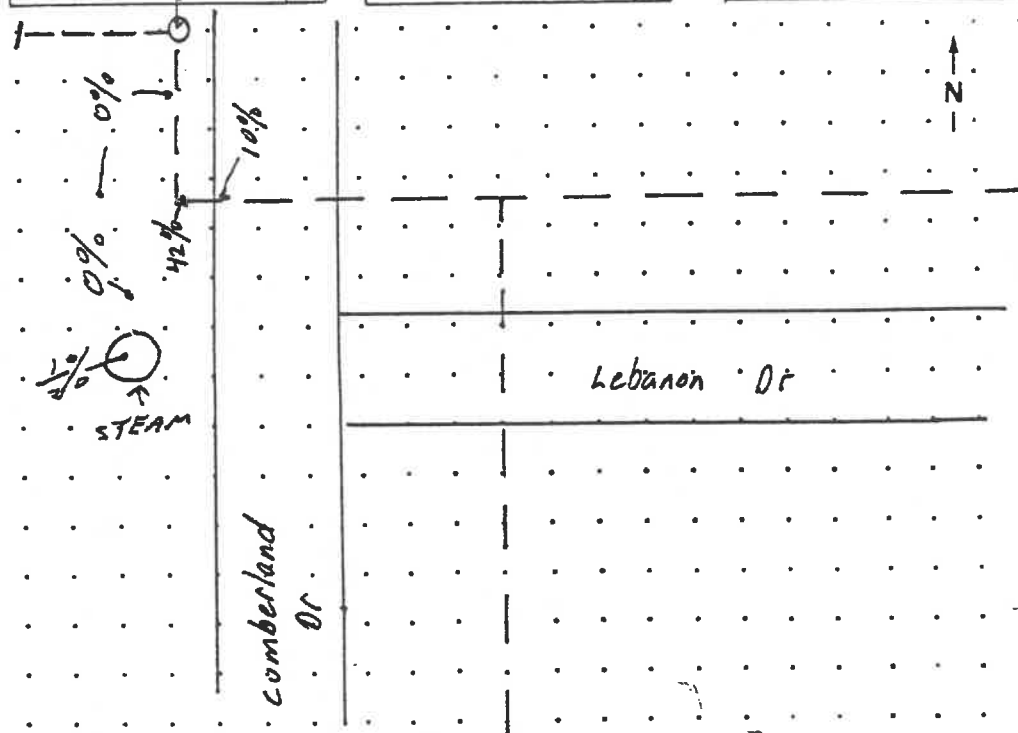
LEAK INDICATION APPEARS TO BE AT:	
Main	<input checked="" type="checkbox"/>
Service	<input type="checkbox"/>
Service Tap	<input type="checkbox"/>
Main at Tie In	<input type="checkbox"/>
Drip	<input type="checkbox"/>
Meter	<input type="checkbox"/>
Curb Valve	<input type="checkbox"/>
Main Valve	<input type="checkbox"/>
Other	<input type="checkbox"/>

Leak appears to be on main. 42% gas @ edge of sidewalk. approx @ main 90° bend

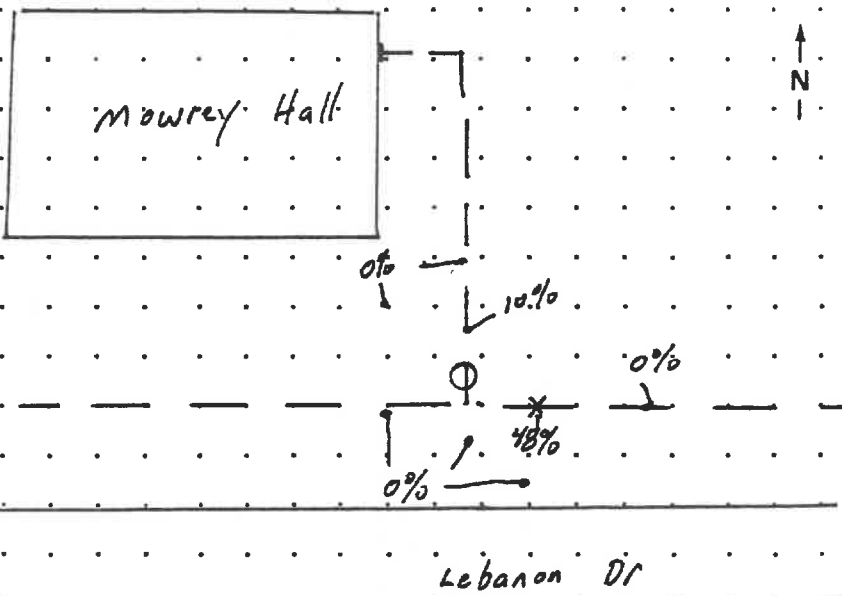
Remarks  
Leak appears to be on main, 48% gas  
approx 5' East of valve 2% gas  
in valve

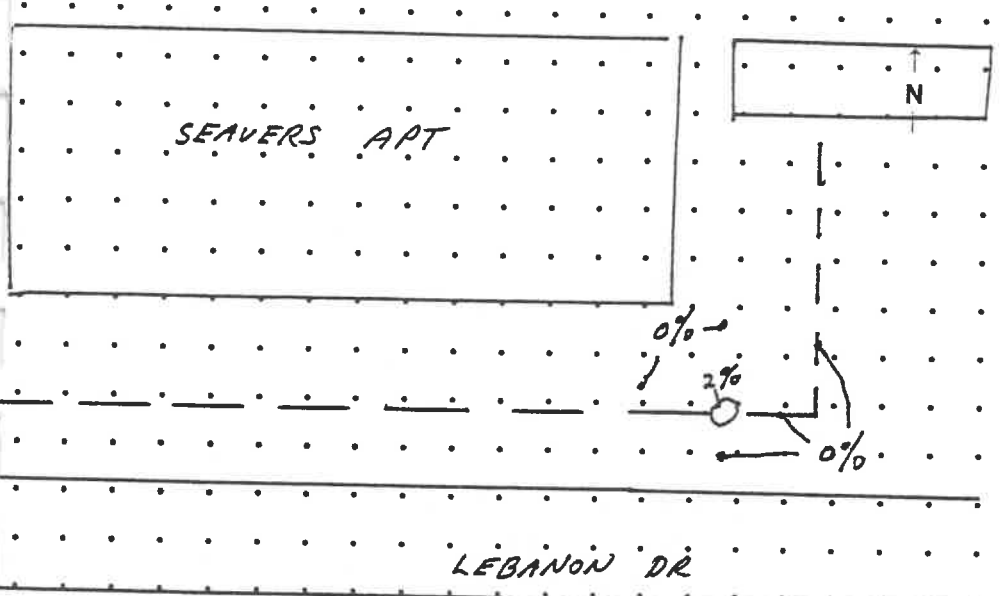
LEAK INDICATION APPEARS TO BE AT:	
Main	<input type="checkbox"/>
Service	<input type="checkbox"/>
Service Tap	<input type="checkbox"/>
Main At Tie In	<input type="checkbox"/>
Drip	<input type="checkbox"/>
Meter	<input type="checkbox"/>
Curb Valve	<input type="checkbox"/>
Main Valve	<input checked="" type="checkbox"/>
Other	<input type="checkbox"/>

Remarks Leak appears to be on valve to east side of Seauvers Hall.

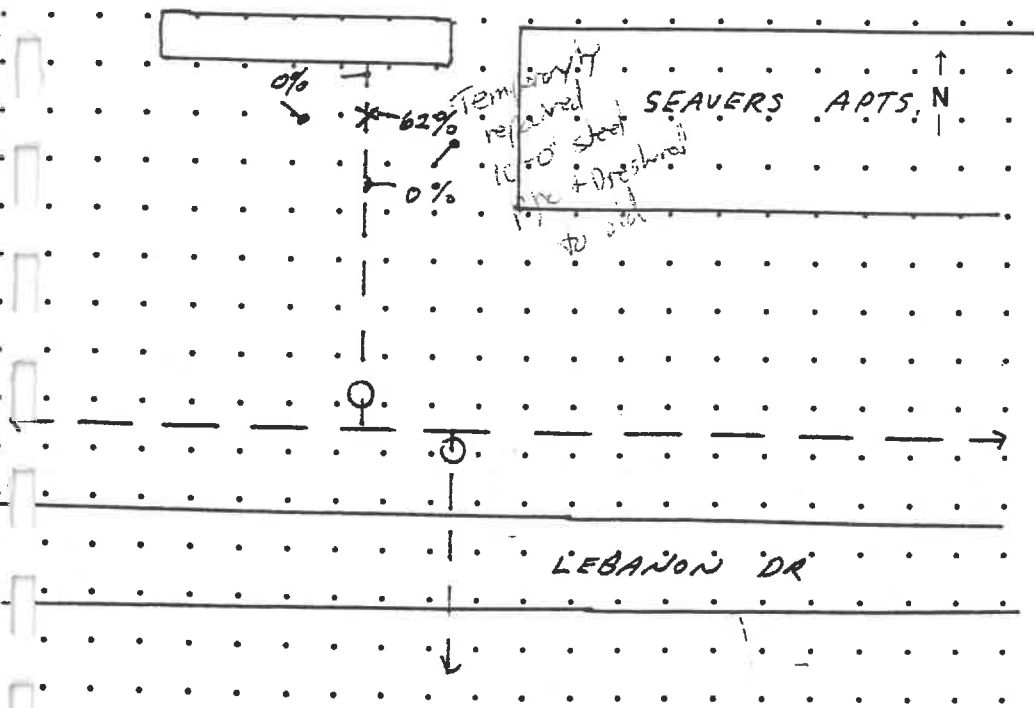
Remarks  
Leak appears to be on service line west side of seavers Hall. 62% gas 4 1/2" south of wall.

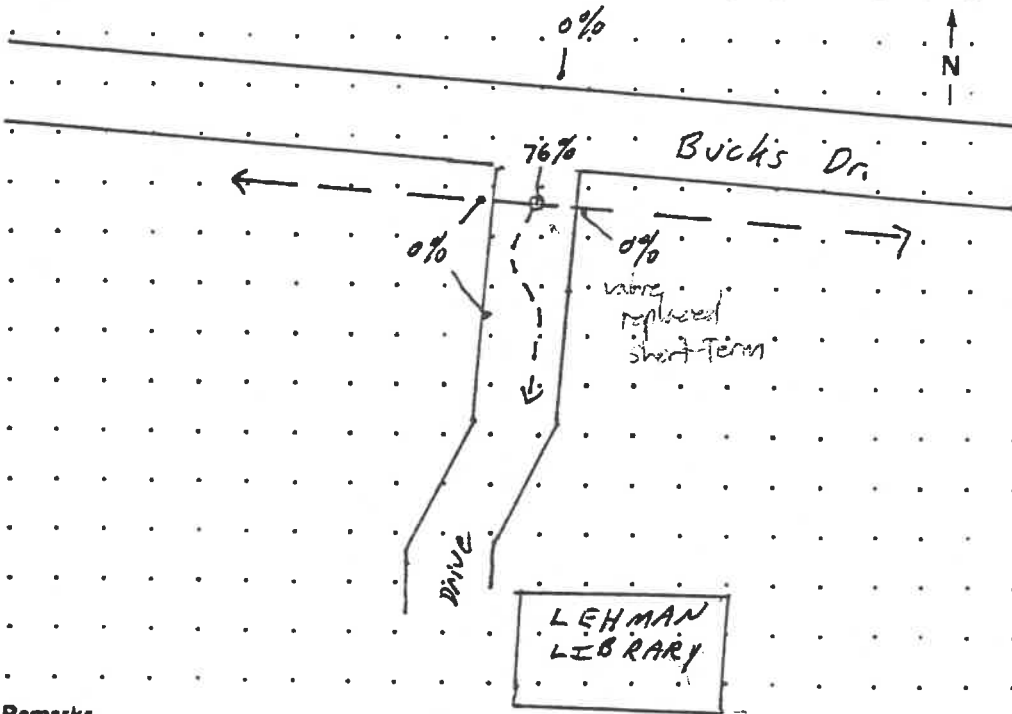
Leak appears to be in valve. 76% gas read.

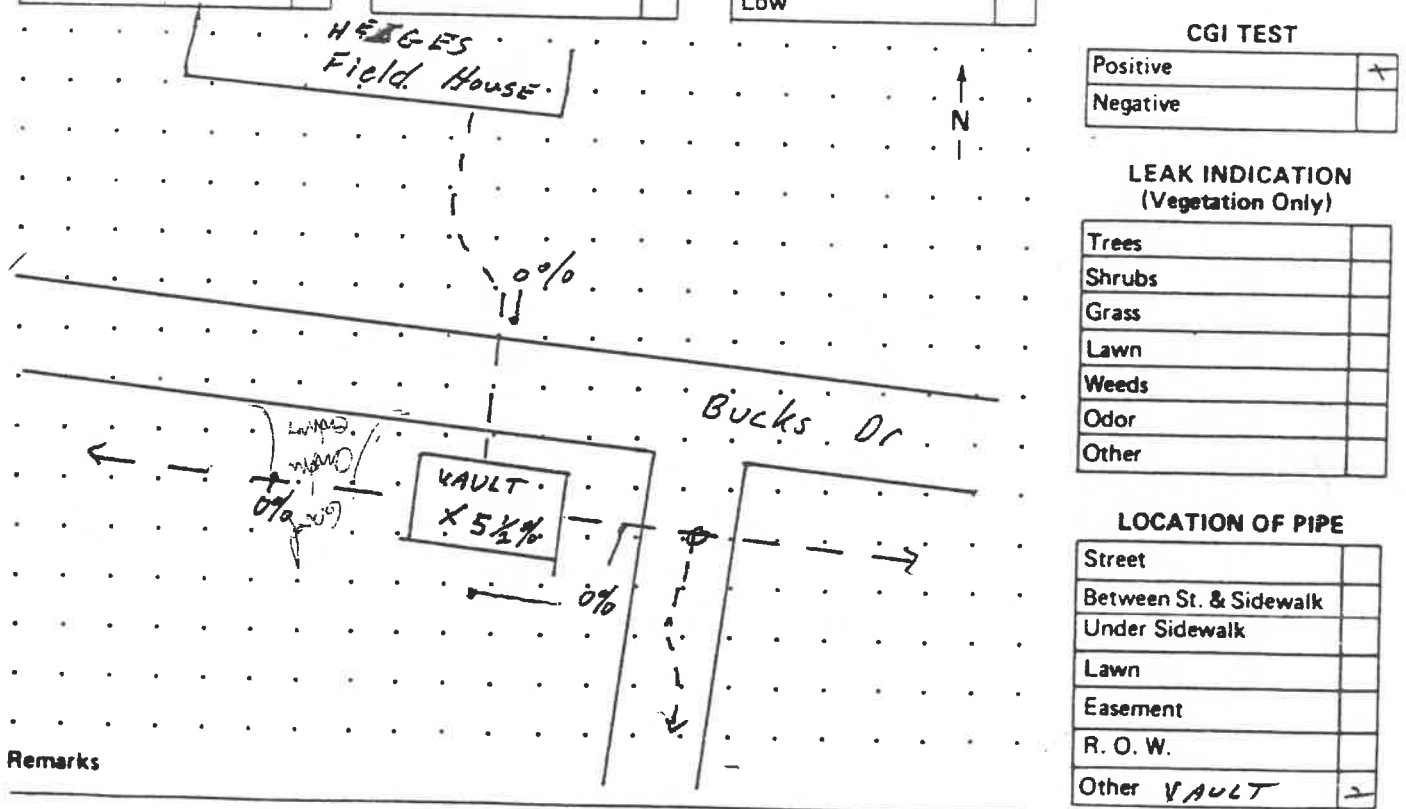
Leak appears to be in vault. 5 1/2% gas read.
