Rehabilitation of The Martin House

FEASIBILITY STUDY

October 2011

Shippensburg University
Shippensburg, PA

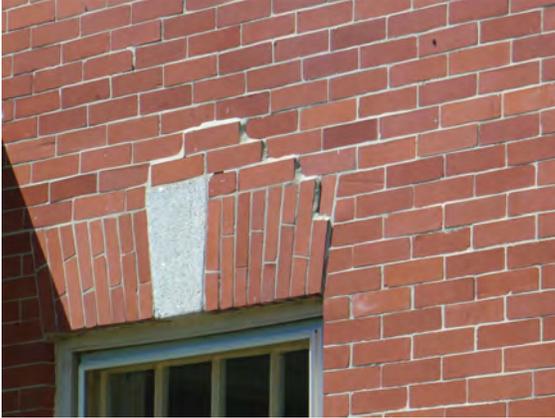
Brick Facades: While in overall good condition, the brick veneer is exhibiting cracking at various locations—such as at window openings and corners. Water is permitted to enter at these locations and will cause on-going deterioration of the brick and back up wall construction, and can promote mold growth within the construction.

Brick lintel movement

Brick facades: The deteriorated window heads will require re-building. The cracks in the joints should be raked to remove any loose or deteriorated mortar and repointed with a matching mortar of the same/similar hardness mortar as the existing mortar. See the structural evaluation of this study for more information regarding this subject.

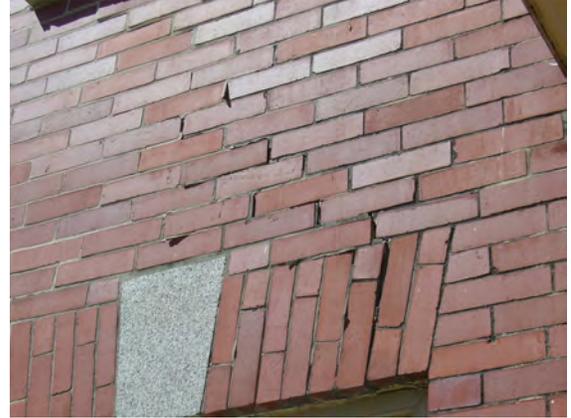
Brick lintel and veneer missing mortar

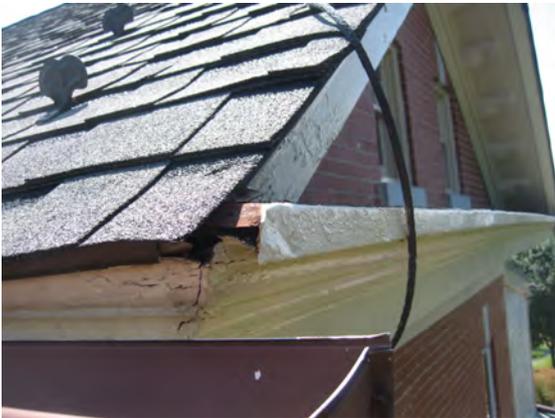
Roof & Gutters: The existing high main roof is an asphalt fiberglass shingle system. The roof has been exhibiting problems of the shingles becoming detached and sliding down into the gutter systems (overdriven nails suspected). On-going maintenance is required and leaking is a constant concern. The roofing shingles were replaced in 1995; the roof sheathing was not replaced then. The roof system is now nearing the end its expected useful life. Lower roofs are standing seam metal and while they have been water tight over the years, they shed water over the top of gutters. The downspout system is not adequately handling the water quantity in a number of locations and is contributing to overflow problems.

Missing roof flashing

Roof & Gutters: This roof system should be replaced with a new asphalt fiberglass system with proper underlayment and ice and water shield, and historically accurate zinc/ lead coated copper valley and other flashings as/ where required. The size, location and routing of the gutter system need to be corrected as part of the re-roofing work and any proposed alterations/ additions undertaken.

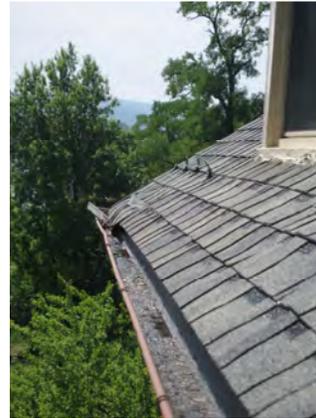
Detached shingles and poor gutter drainage

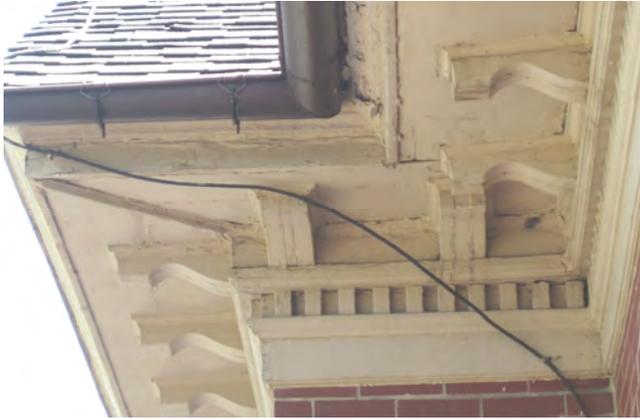
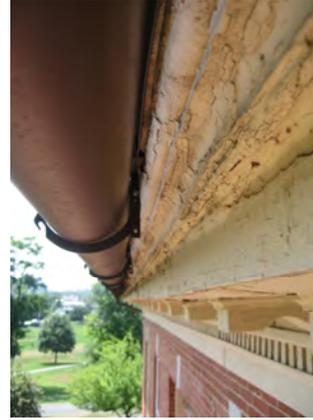
Historic Wood Cornice: A careful inspection of the wood elements revealed that parts of the cornice are deflecting and deteriorating – primarily the soffit board and fascia. It is becoming more difficult to paint with each successive painting cycle (more and more extensive filler, sealant and preparation). The main decorative brackets and dentil work are not exhibiting as much deterioration.

Deteriorating cornice

Historic wood cornice: A distinguishing feature of the residence is its built-up, painted, decorative wood cornice. The work at the cornices will involve the removal and replacement of the soffit and fascia wood/ boards with high quality painted wood components. Brackets and other trim appear to be adequate and will require scraping, sanding and proper preparation for painting as part of the cornice re-building effort. Some corrective work of the substructure blocking and sheathing should be anticipated.

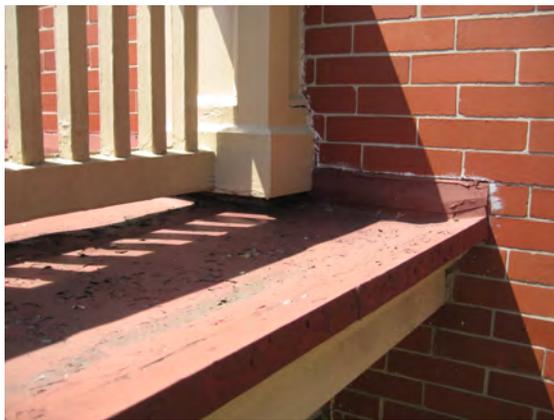
Miscellaneous exterior wood trim/ porches: Existing front and small rear porches, as well as the sunroom, are constructed of historically accurate wood components and are distinguishing features of the historic home. These components are deteriorated at various locations and are ongoing maintenance problems.

Front porch roof wall connection

Miscellaneous exterior wood trim/porches: The railing and other trim pieces must be patched and repaired and in many instances, new matching high quality wood painted components must be fabricated and installed by skilled craftsmen/ carpenters experienced in this type of work.

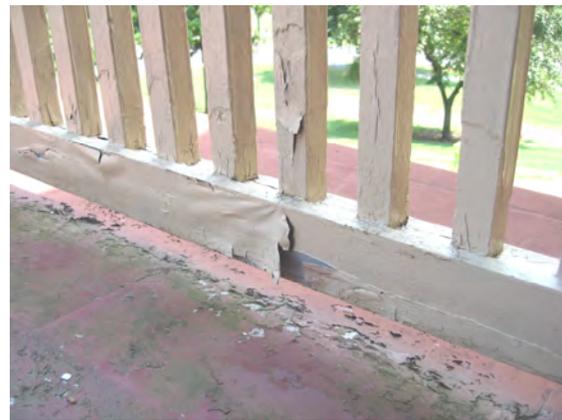
Deteriorated front porch roof

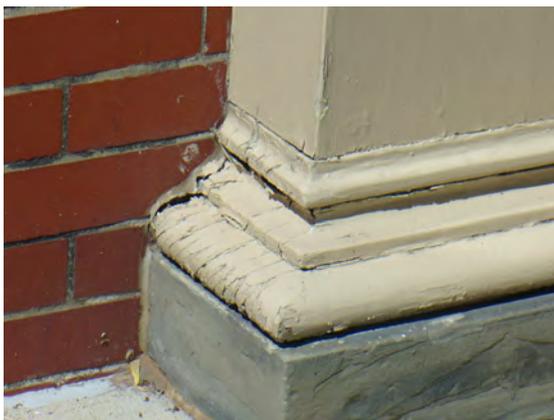
Separating front porch pilaster

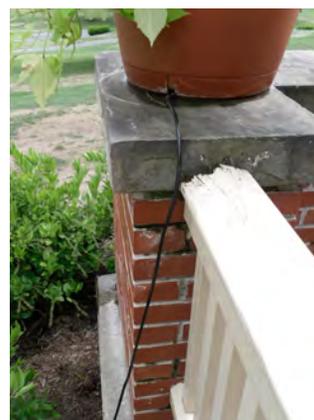
Deteriorating handrail and brick corner

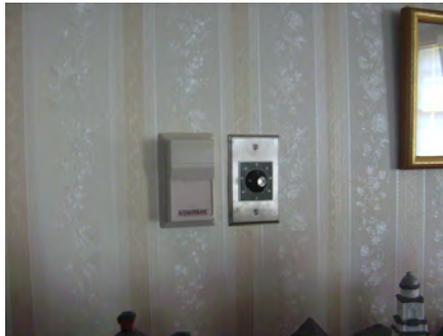
The existing perimeter baseboard heating loop is served by a single temperature sensor located in the living room. This leads to poor control of this system as individual spaces may be over- or under- heated depending on what the living room sensor is reading and actual load conditions for the space.

Perimeter Baseboard Sensor

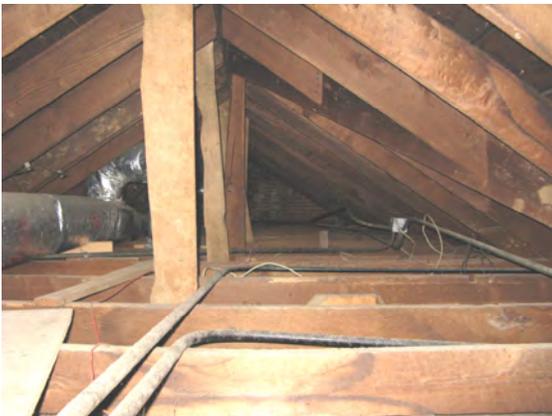
- a. The original roof framing, viewed from the attic access hatch, appears to be in generally good condition. Framing consists of 2x8 rafters at approximately 24 inches on-center. We observed one split rafter. See Photographs 1 and 2.

Photograph 1 – Attic framing.

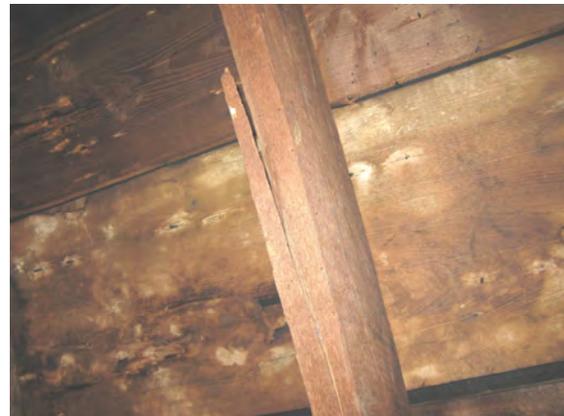
Photograph 2 – Split rafter.

- a. The split roof framing member should be sistered with a new 2x8.
- b. The concentrated loads on the third floor should be spread out, or the floor framing reinforced for light-storage loading.
- c. New mechanical equipment was added in 1995. An air handler appears to be suspended from third floor ceiling joists. No signs of structural distress are evident. See Photograph 3.
- d. Reinforce the Guest Room floor framing to level the floor and provide increased load capacity.
- e. Re-frame the third floor stair header and stringers to remove the uncomfortable and hazardous slant.

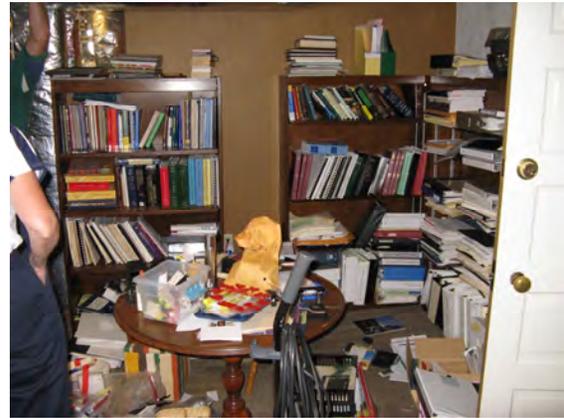
Photograph 4 – Paper, books, and notebook storage on third floor

- c. The rooms on the north side of the third floor are used as storage rooms. A concentration of books, notebooks, and file cabinets occurs in a small area of the larger room. A separate smaller room to the east is used as clothing storage. Although no distress was observed, this historic structure was not designed for this loading. See Photograph 4.
- d. The floor of the Guest Bedroom is noticeably sloped down to the center of the room. See Photograph 5. Nails have been installed from the surface of the finish flooring into joists spanning east-west in an attempt to minimize squeaking. The floor joists span from the east wall to a partition wall on the second floor between the study and the Master Bedroom. This second floor partition is then supported on concealed beams in the first floor Living Room ceiling.

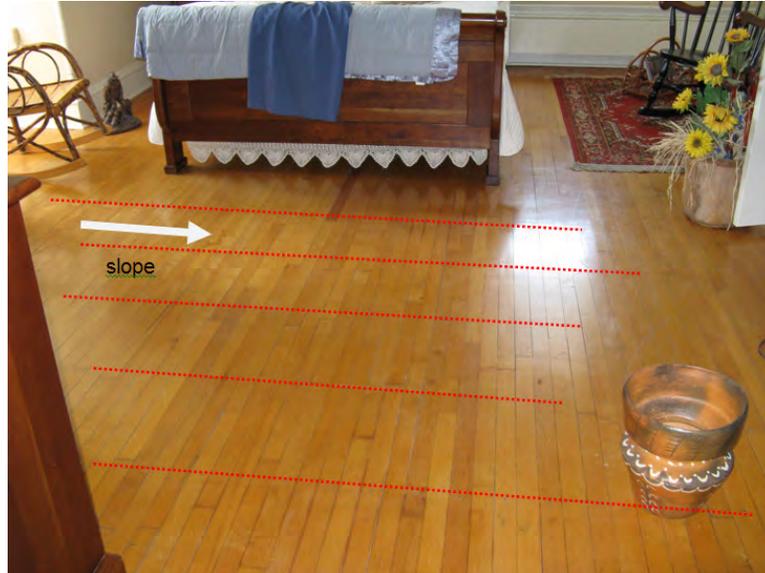
The deflection in the Guest Room floor is likely due to a combination of initial sagging of the timbers, the size of the floor framing, and the accumulation of loads causing long-term deflection of the framing. Sleeping room framing in similar historic structures of this period is typically 2x8 joists at 16 to 24 inches on-center.

Photograph 5 Sloping Guest Room floor showing nail lines.

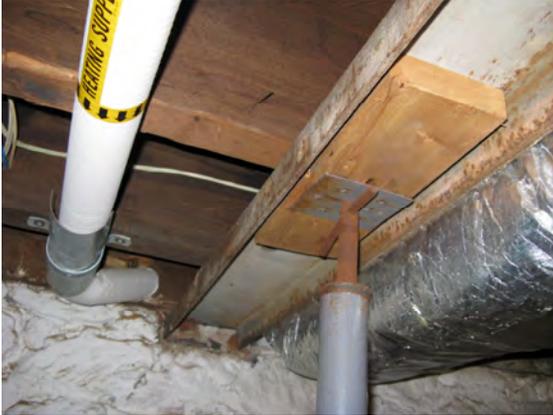
3. First Floor Framing
 - a. The first floor framing consists of 3x10 joists, spaced at 16 inches on-center, and supported by stone foundation walls and a mix of interior brick piers, walls, and built-up timber girders. There are additional steel posts and shoring beams supporting the framing at the stair opening, below the Dining Room partition, and below the front of the Family Room. See Photographs 7 and 8. We do not know when these elements were installed.

Photograph 7 Shoring below Family Room

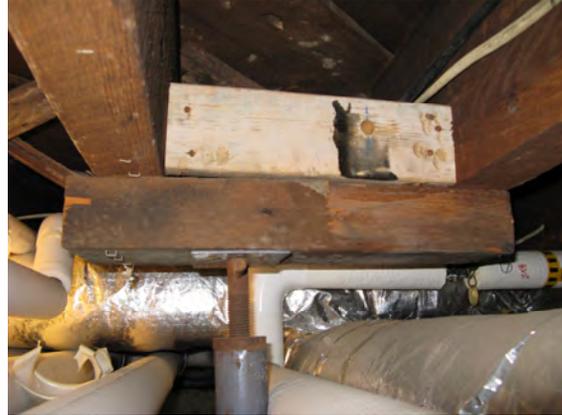
Photograph 8 Shoring below first floor

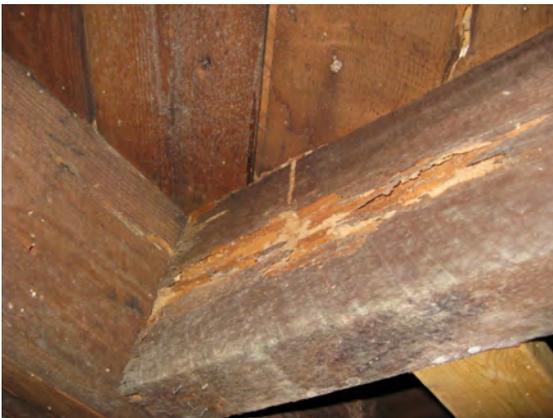
- b. Joists with wood-boring insect damage were observed. See Photographs 9 and 10.
 - c. One floor joist was locally cut by the installation of a duct.

Photograph 9 Insect damaged first floor joist at north wall.

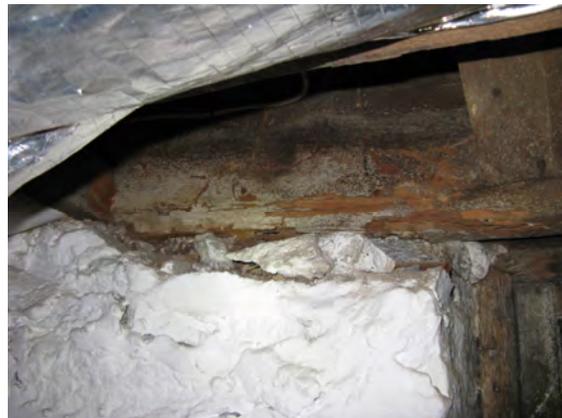
Photograph 10 Insect damaged first floor joist, southeast corner.

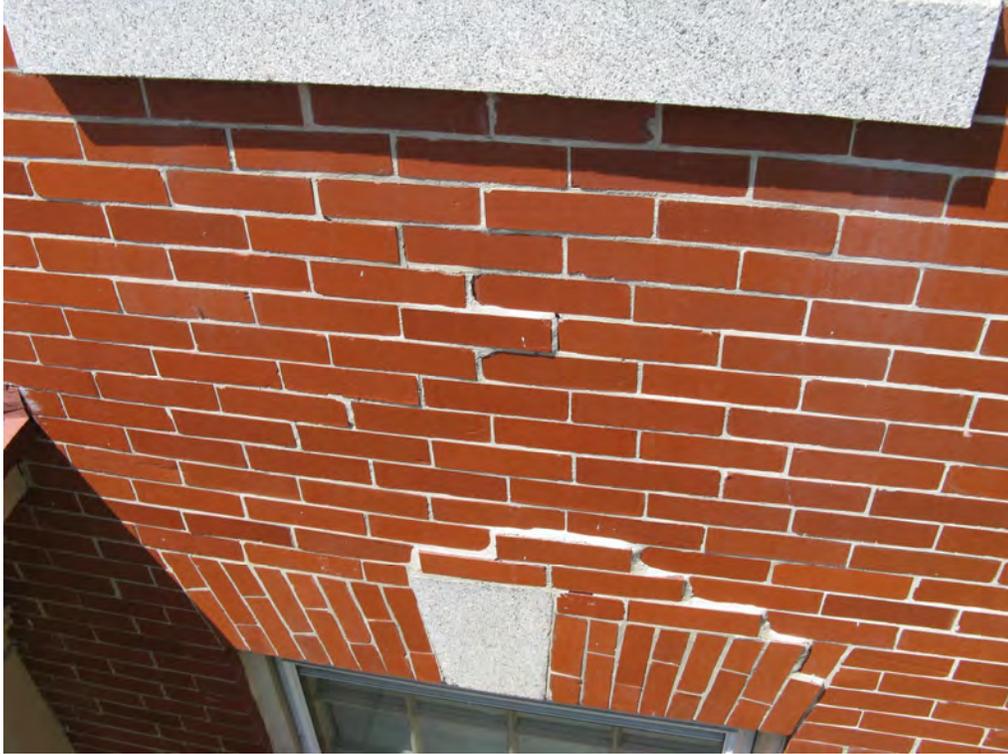
- a. The exterior walls are multi-wythe brick. Window lintels are flat-arches with a limestone keystone. A number of flat arches have failed, particularly at the first floor on the east elevation. Cracks and displaced bricks also occur above the lintels. Previous mortar patches are visible. No interior wall damage was observed in areas behind deteriorated arches. See Photographs 11 and 12.

Photograph 11 Flat arch lintel above north-east Family Room window.
Note out of plane movement

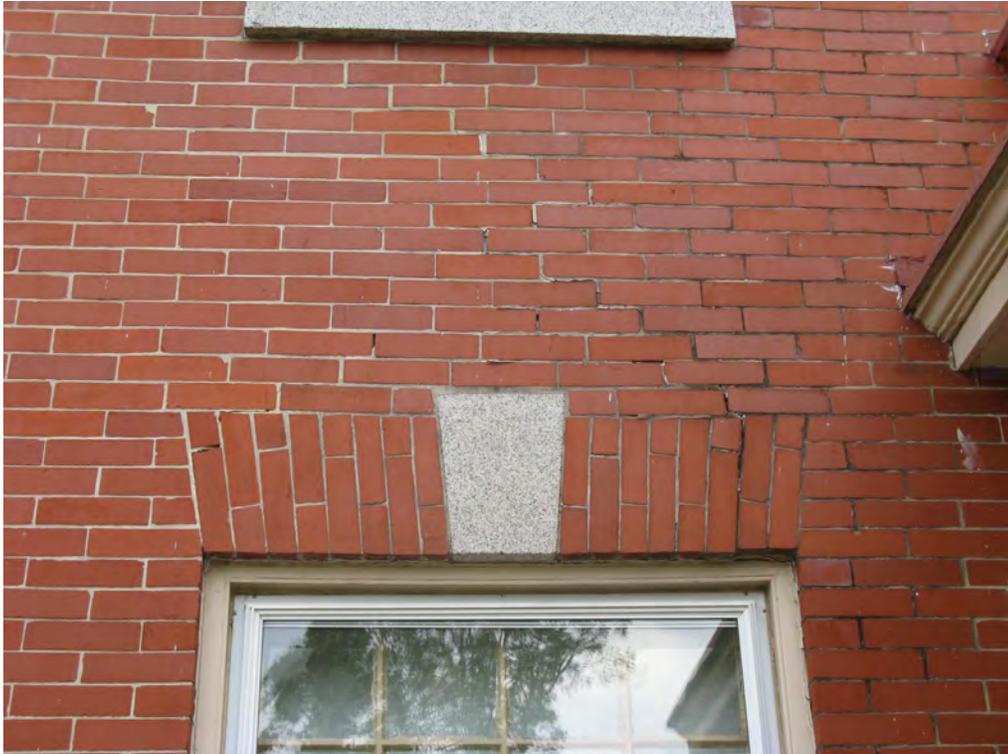
Photograph 12 Flat arch lintel above south-east Living Room window
Note open joists and deflected arch

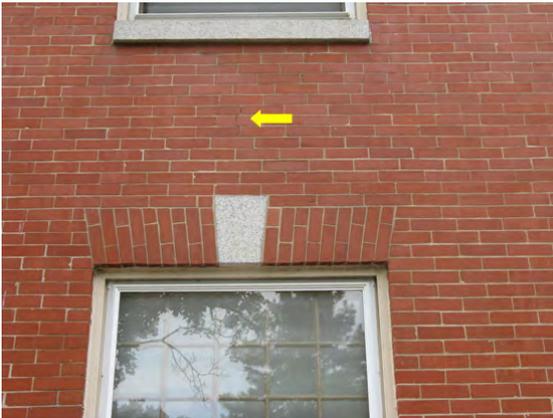
- b. A vertical crack exists between the first floor lintel and the second floor sill at the north-east windows.

Photograph 13 Crack in brick above northeast window

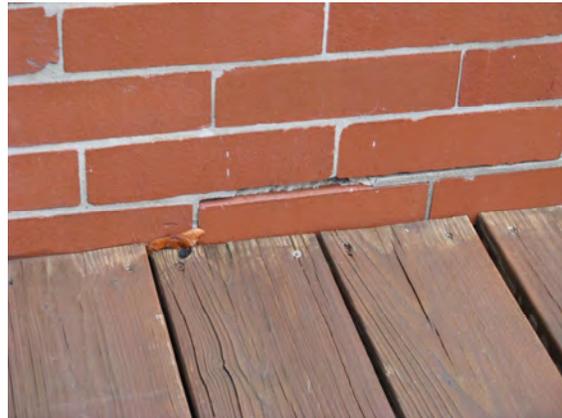
Photograph 14 Loose brick south west wall.

- c. A loose brick was observed at the deck level on the south west wall. See Photograph 14.
- d. Three chimneys extend above the roof. The mortar joints in the corbelled brick and concrete caps are loose, and in some areas, missing. Moss is growing on the corbelled brick shelves. See Photographs 15 through 17.

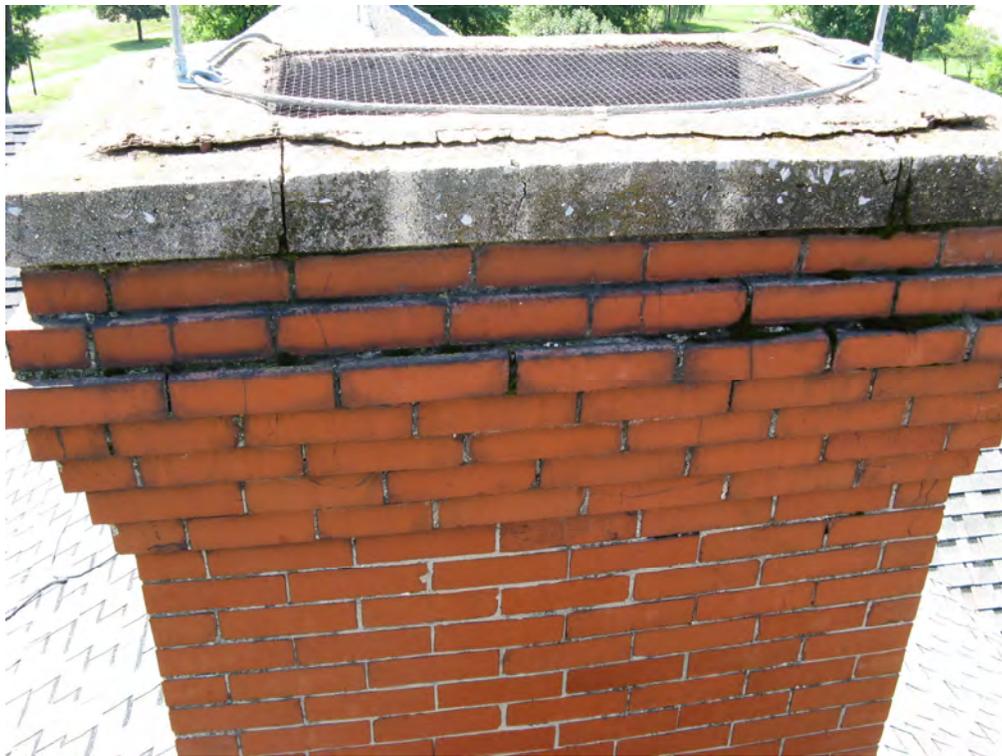
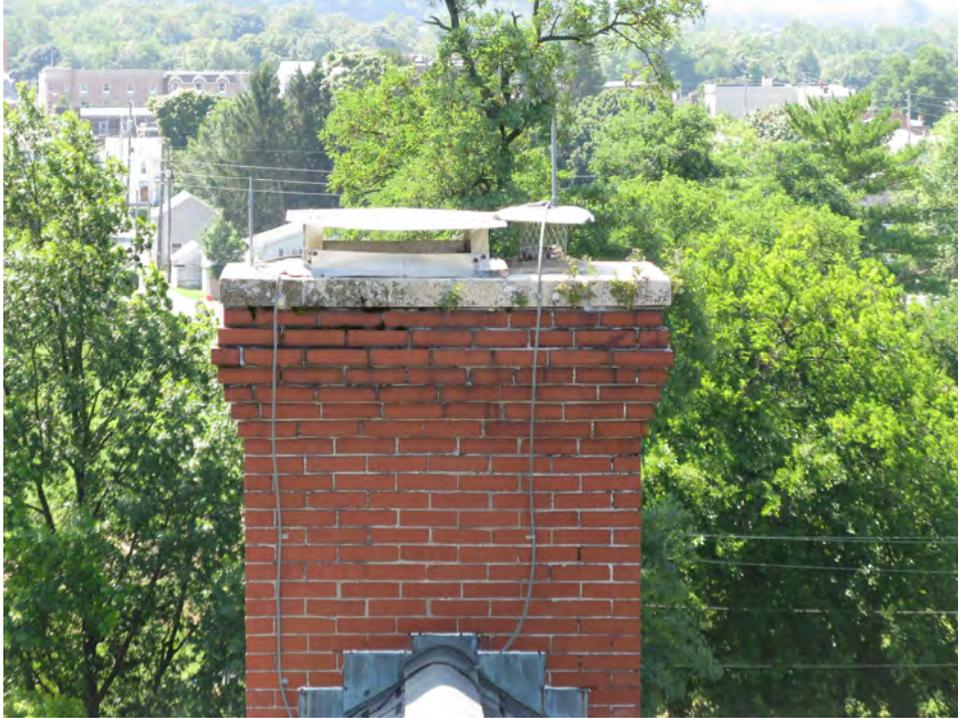
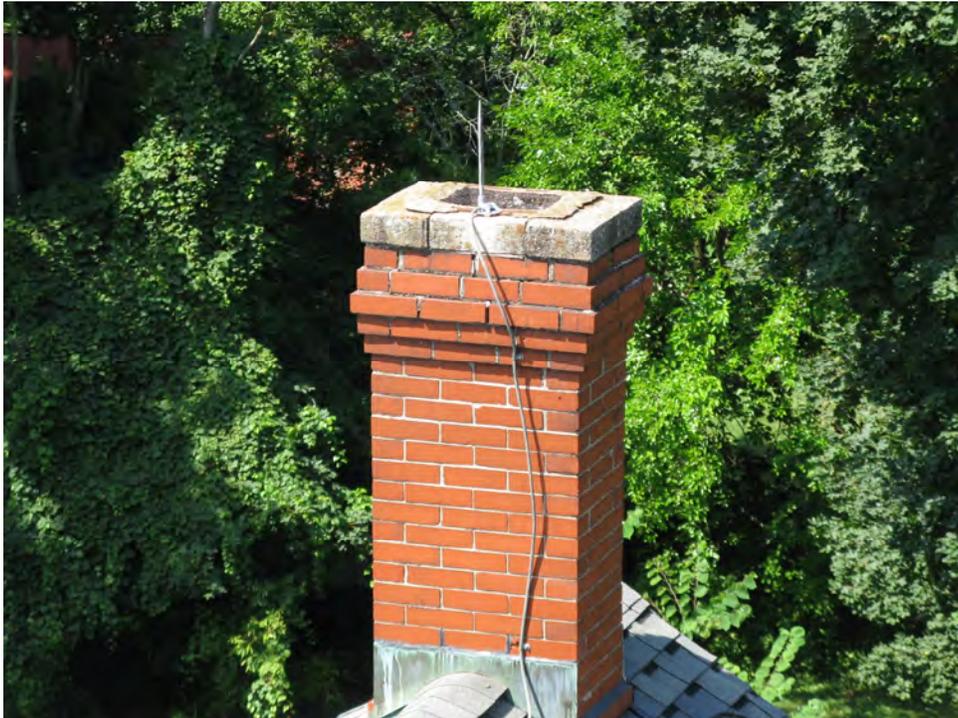
Photograph 15 Top of north chimney

Photograph 16 South chimney

Photograph 17 West chimney

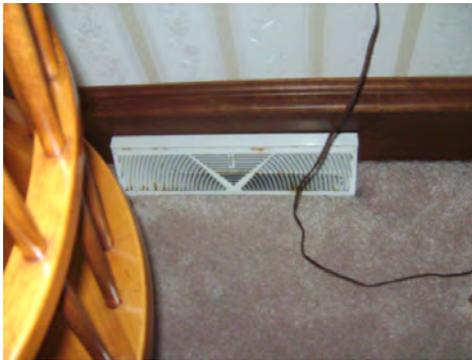
- c. Several of the air devices are in poor shape and some have begun to corrode. Evaluate the air devices for replacement and replace as necessary.

Existing Air Device

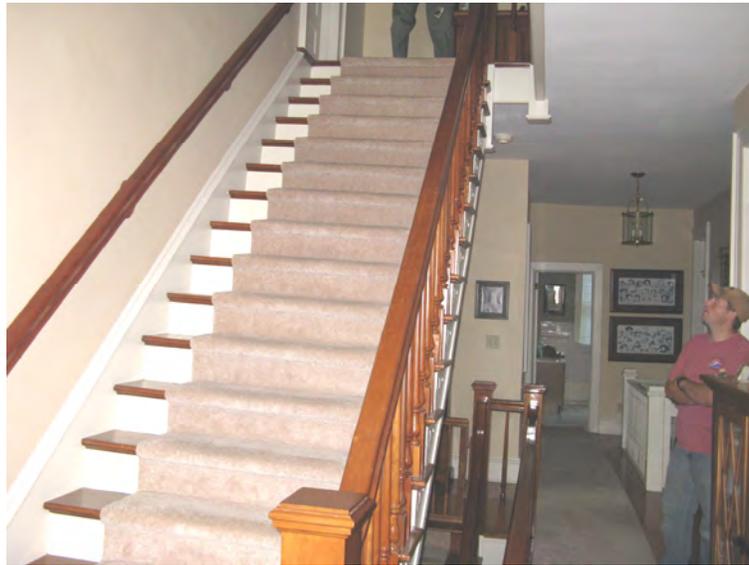
- e. The stairway between the second and third floor slopes to the open side of the stair, particularly at the third floor landing area. No distress in the wood trim or in the plaster soffit is visible. See Photograph 6.

Photograph 6 Stair to Third Floor – slopes to open side
