Implementing a long-term monitoring system on the restored Conococheague Creek  
following removal of Birch Run Dam

**By**  
**James J. Manuel**

A Thesis submitted to the  
Geography-Earth Science Department  
and the Graduate Council  
in partial fulfillment of the requirements for the degree of  
Master of Science

Shippensburg University  
Shippensburg, Pennsylvania  
December 2009

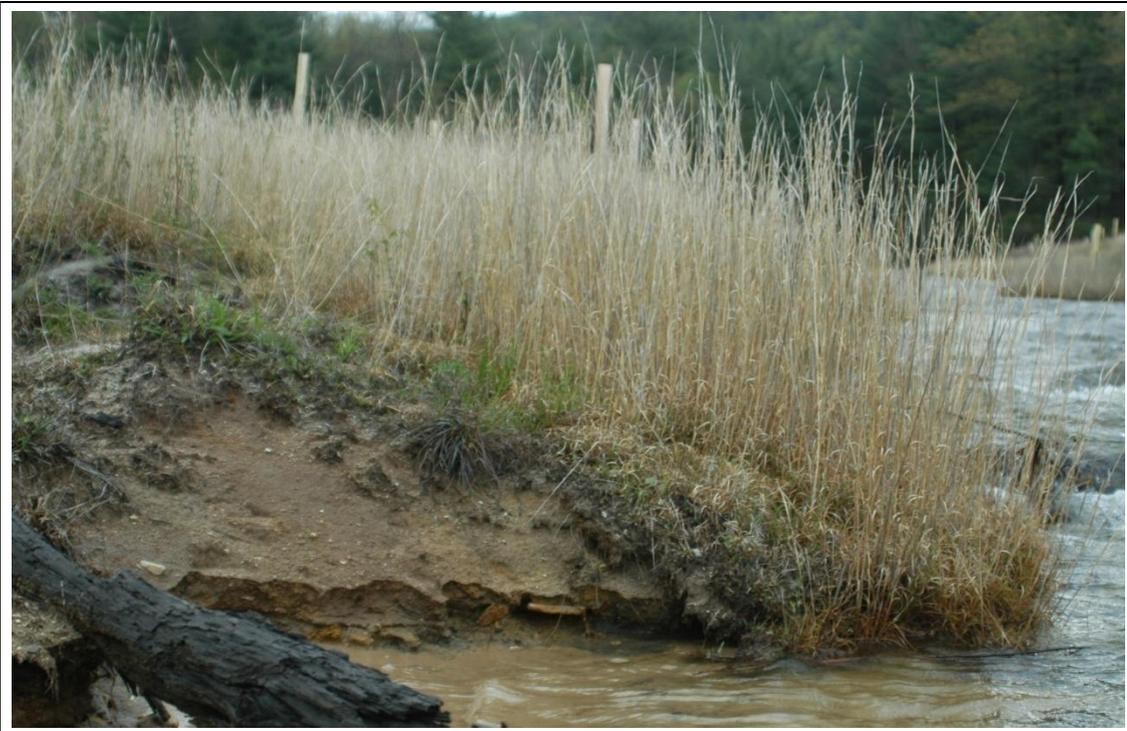
Figure 3. An example of the material deposited near the upstream extent of the former Chambersburg Reservoir behind Birch Run Dam. The image is looking upstream along the right bank of the Conococheague Creek (author's image dated, 07.May.2009).

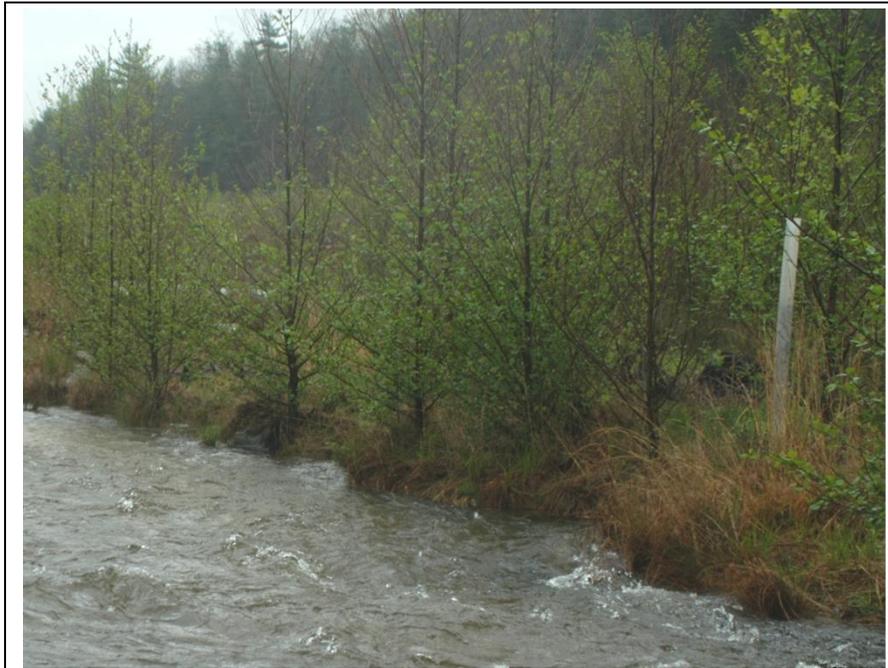
Figure 10. Image of the vegetation on the left bank of the *Alpha* reach. The left side of the channel has a far denser distribution of trees as compared to the right side (author's image dated, 7.May.2009).

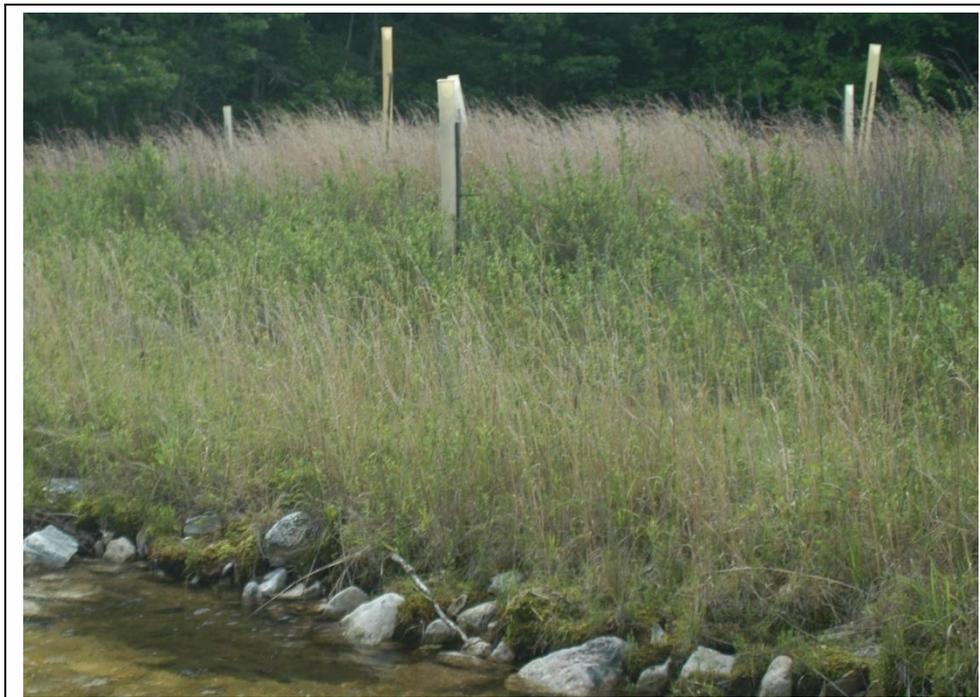
Figure 13. Image of the vegetation along the left bank of the *Bravo* reach. Note the slight change to shrubs at the toe of the upper bank and then returning to grass on the flood plain (author's image dated, 29.May.2009).

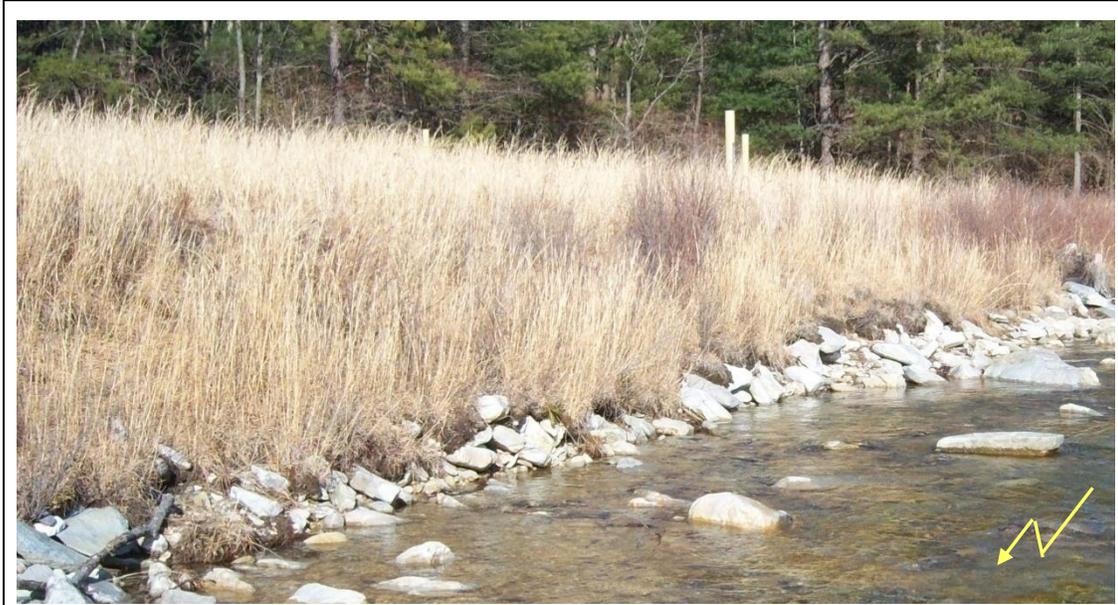
Figure 14. Image of the cobble-sized armoring along the right bank of the *Bravo* channel. Grasses are dominant cover along the majority of the bank (author's image dated, 05.March.2009).

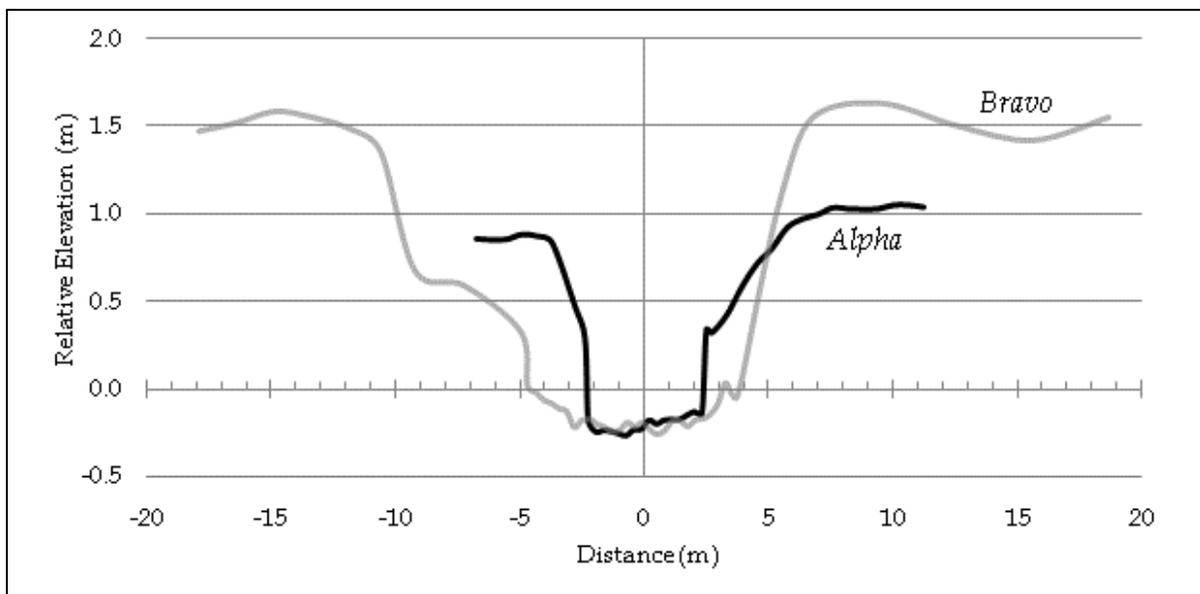
Evidence of undercutting and slope failure at the *Alpha* and *Bravo* reaches, respectively, indicate differing bank responses to high flow events. The banks of the *Alpha* reach are comprised of cohesive material, thus the entire bank does not fail in response to erosive action (parallel or impinging flow). The *Alpha* bank is undercut which displays exposed tree sapling roots in the riparian zone and previously buried stumps. If the entire undercut area of the *Alpha* left bank fails, the channel width could increase by 0.5 m (10%). The increased cross-sectional area could have dramatic impacts on the connectivity of the channel with the flood plain. The cohesive clays that comprise the banks, in addition to the sapling roots, are currently preventing collapse.

Figure 16. Comparison of studied cross-sections along the Conococheague Creek upstream of the former Birch Run Reservoir. Data are from the March field reconnaissance. The water line on the day of observation is represented by the zero elevation mark.

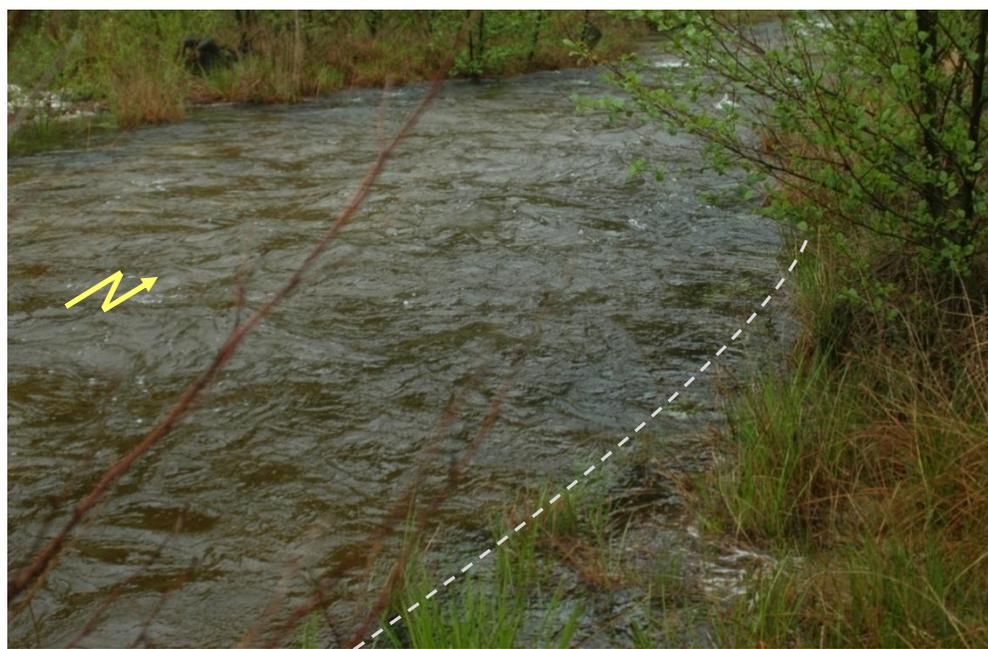
Figure 17. Image of the *Alpha* reach flowing slightly above the lower bank following 7.9 cm of rain over five days. The location of the lower bank edge is approximated by the dashed line (author's image dated, 07.May.2009).

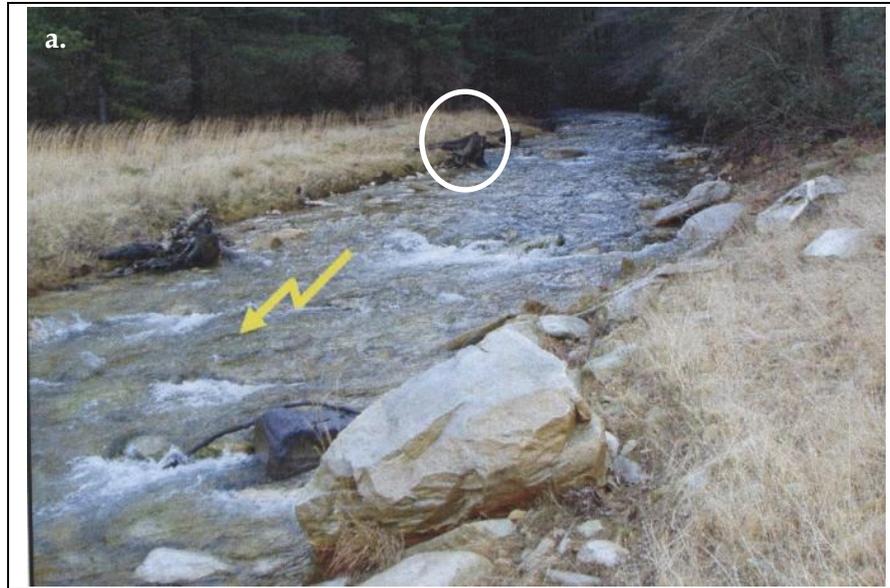
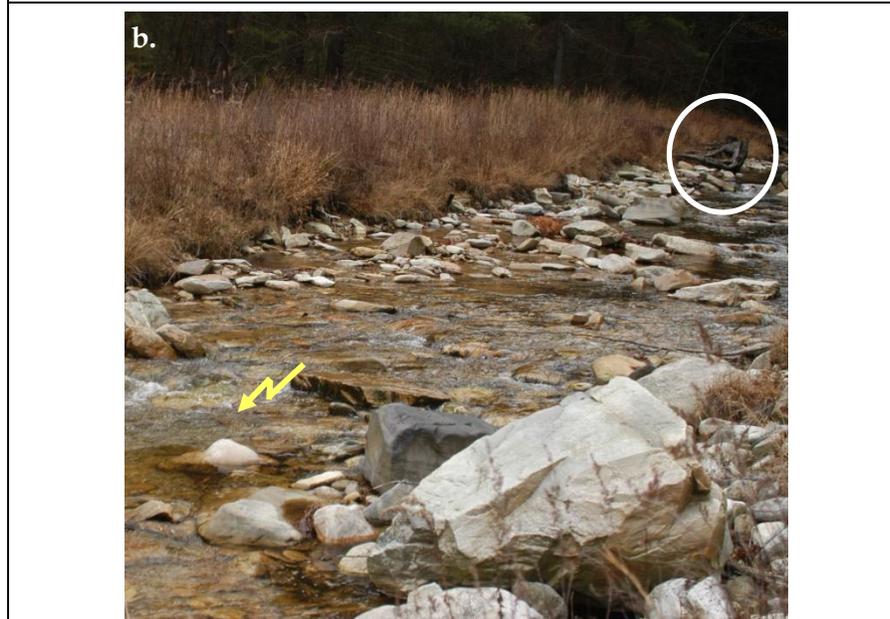
Figure 18a. PA DEP file image of the *Bravo* reach taken in 2005 during a Phase I assessment of the adjacent wetland.

The *Bravo* reach appears to be shifting from the 'Degradation Stage' (Stage III) to the 'Threshold' Stage (Stage IV) of the Simon and Hupp (1986) CEM. Stage III is characterized by taller/steeper banks; pop-out failures, and a lack of alternate bars. Stage IV is dominated by mass wasting, while bed erosion may still continue. All of these conditions appear to be

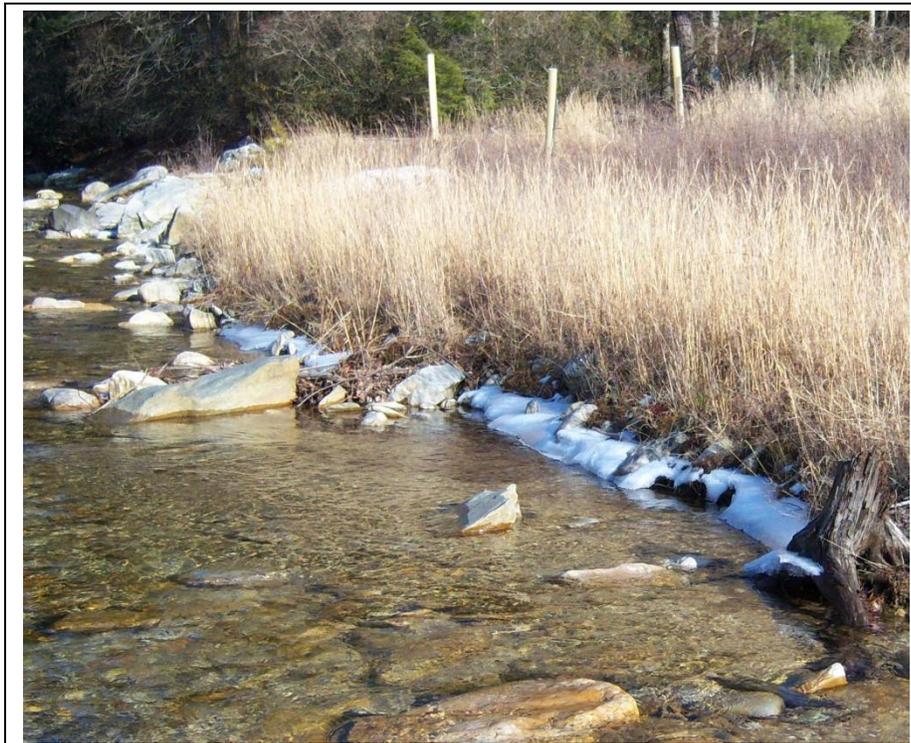
Figure 19. Image of sand and gravel deposited along the left bank of the *Bravo* reach. Future growth and established permanence of this deposit may indicate an increasingly stable channel form (author's image dated, 5.March.2009).

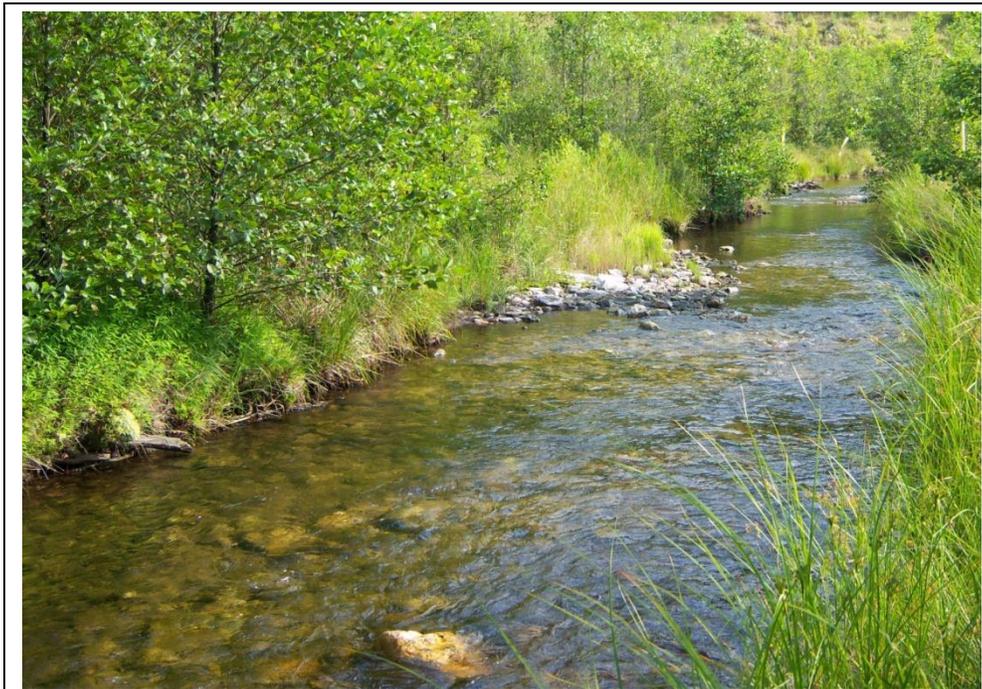
Figure 21. Image of point-bar development downstream of the *Alpha* reach of the Conococheague Creek. Note the colonization of vegetation on the point bar (author's image dated, 9.July.2009).
