FACILITY STUDY – SU 2004/15
Facilities Detailed Project Planning Document
DAUPHIN HUMANITIES CENTER
SHIPPENSBURG UNIVERSITY PA

| 2.00 | RECOMMENDATIONS..... | 2 |

1.00 PURPOSE AND GOAL

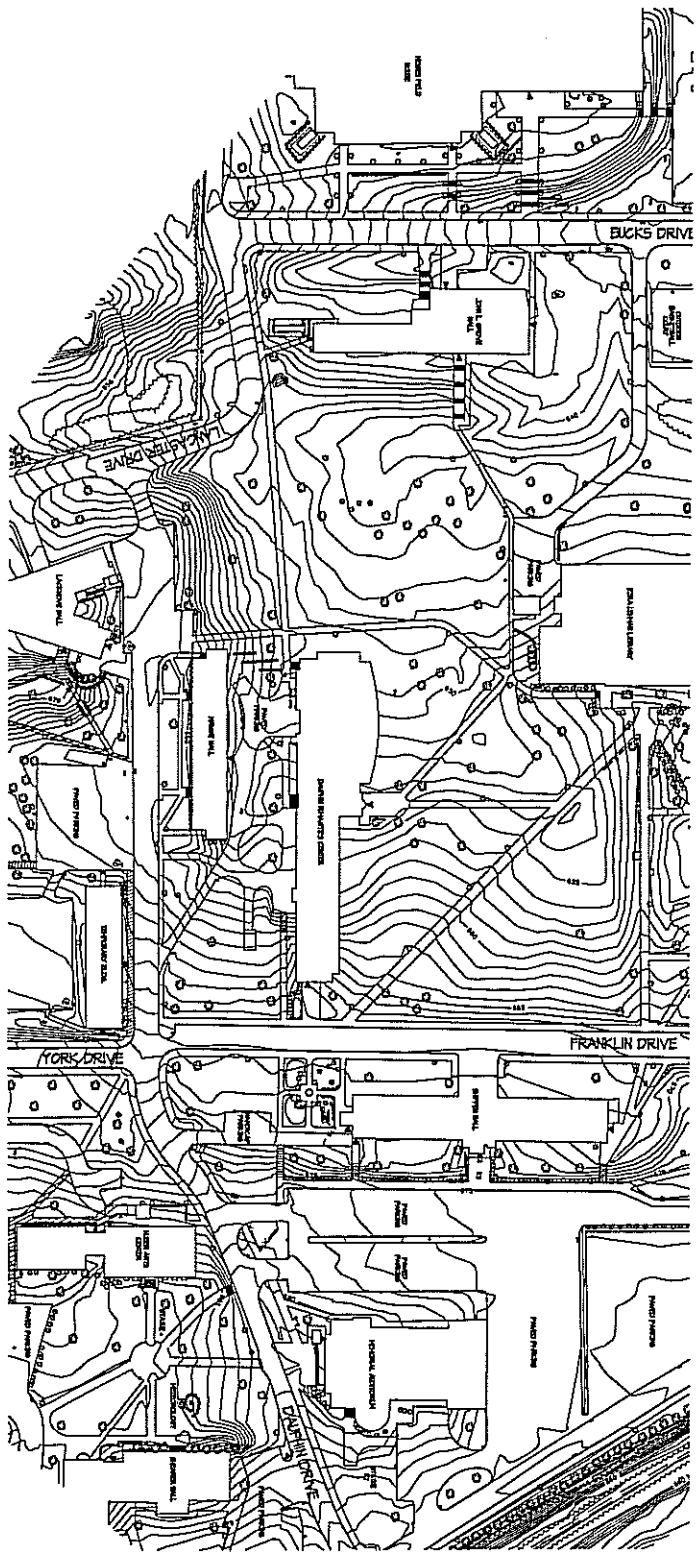
EXISTING PARTIAL CAMPUS PLAN
SCALE: ONE INCH EQUALS FIFTY FEET

INDICATE ACCESSIBLE DRIVEWAY
