Rehabilitation of Stewart Hall

FEASIBILITY STUDY

October 2014

Shippensburg University
Shippensburg, PA

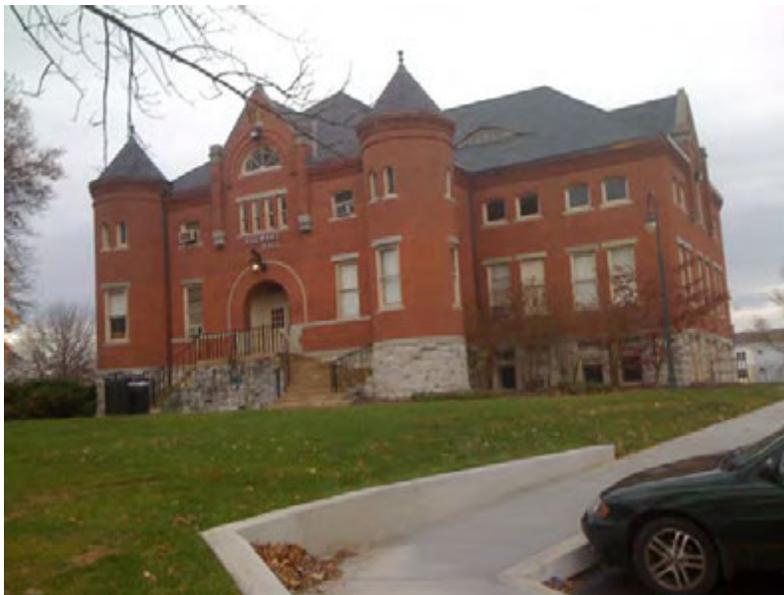
Southeast/ Main Entry Elevation

Ascending either of the two exterior main entry stairs, on the south face of Stewart Hall (towards Old Main Drive), will lead directly into the main vestibule of the facility at the First Floor. Directly to the east and west, upon entering, are the two prominent turrets. To the north of the main vestibule are two sets of “original” historic stairs, both of which go to all three levels. Continuing through the main stair vestibule area and past the two sets of stairs, one enters a central corridor. The corridor extends west to east and leads to a rear fire stair exit.

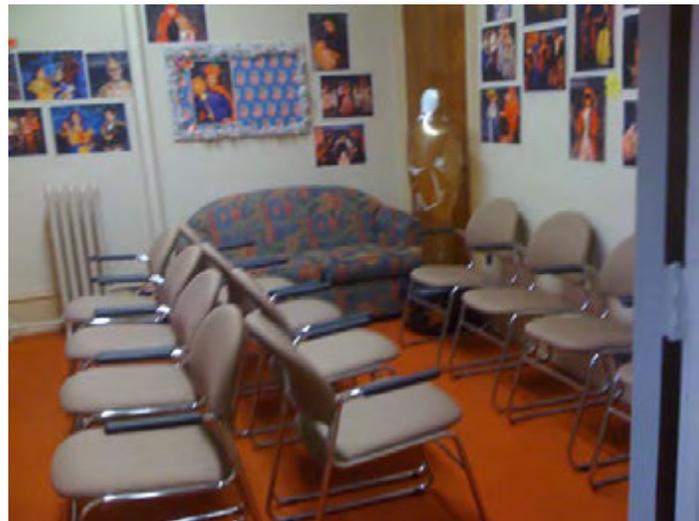
The Lower Level is accessed from the entry stair on the left upon entering the main vestibule. The men’s restroom can be found at the southwest corner and the women’s can be found on the southeast corner, at the bases of the prominent corresponding turrets. In addition, the mechanical room can be found at the northeast corner with a small exit door accompanied by 5 stair risers, which exits to the east. An existing ramp to can be found at the exterior northwest corner which descends from grade level to the lower floor. Throughout the Lower Level are existing rooms of various sizes, which are mainly used as storage areas for the University.

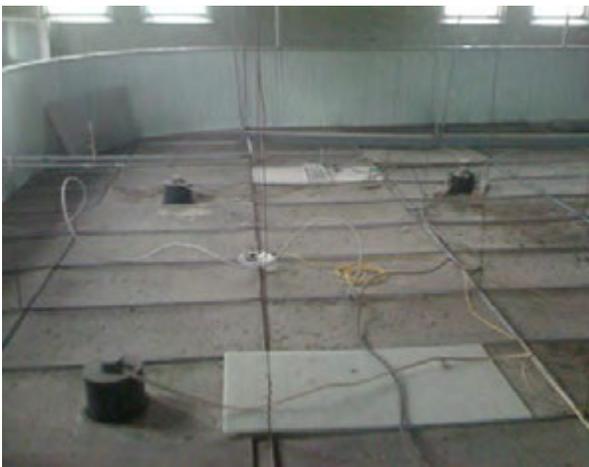
Suspended Historic Track/ Lay in Ceiling

The second floor is accessed from the two main entry stairs from the first floor and both lead to the central enclosed corridor and the historic suspended indoor track. Located on the south side are two storage/ studio areas which occupy both of the turret areas on the east and west. In the central area of the south is an existing room that is used for storage. A door on the west end of the central hallway exits to the historic suspended indoor track once used by Olympian Jim Thorpe. Originally, the track was open to the first floor, but at some point, through its many years of history, a drop ceiling was added to conceal the track and hide the current mechanical equipment that supplies the facility.

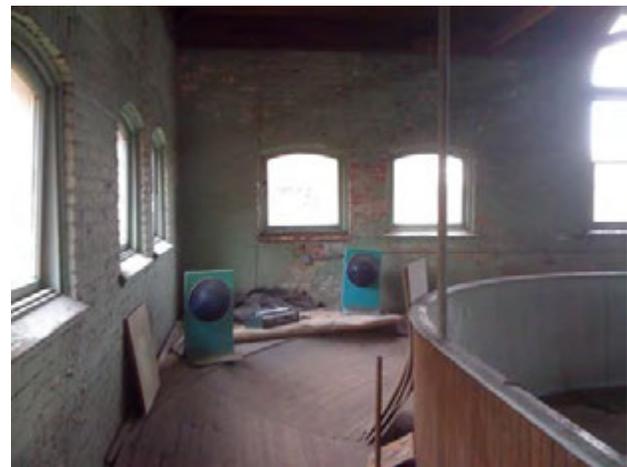
Suspended Historic Track

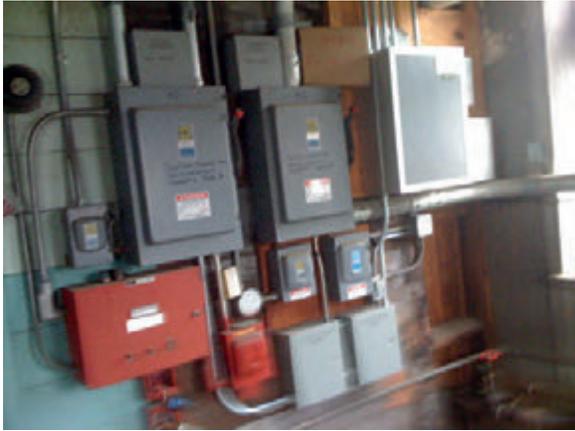
Lower Level - Mechanical Room

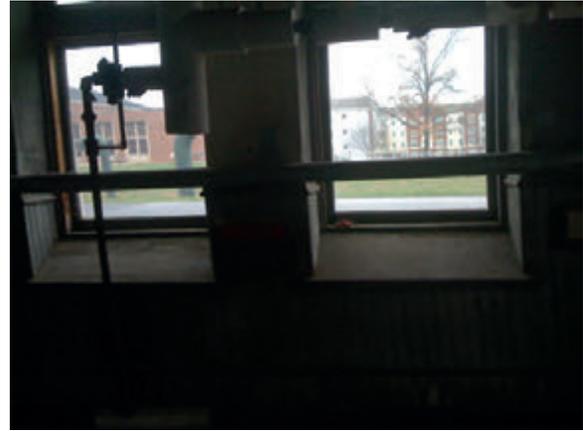
Lower Level - Mechanical Room

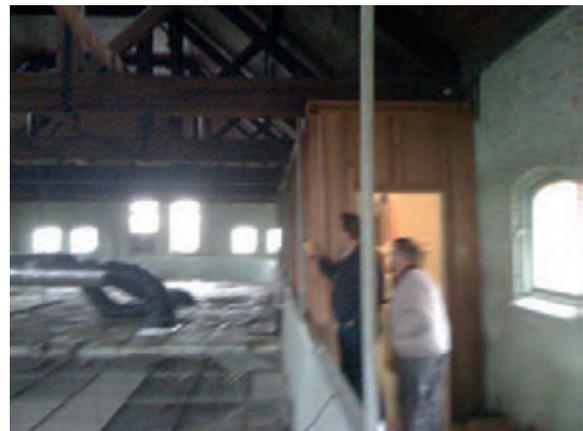
Second Level - Track Area

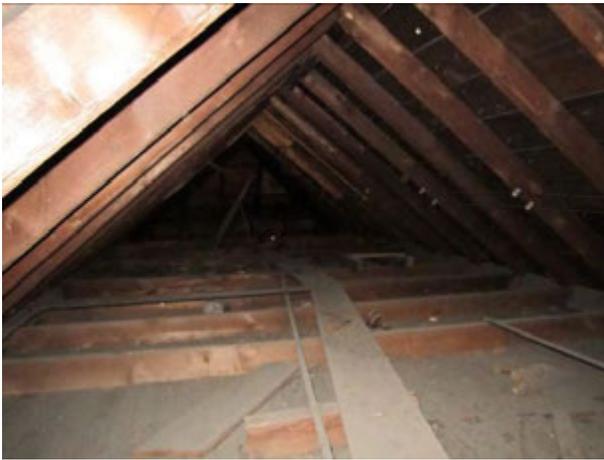
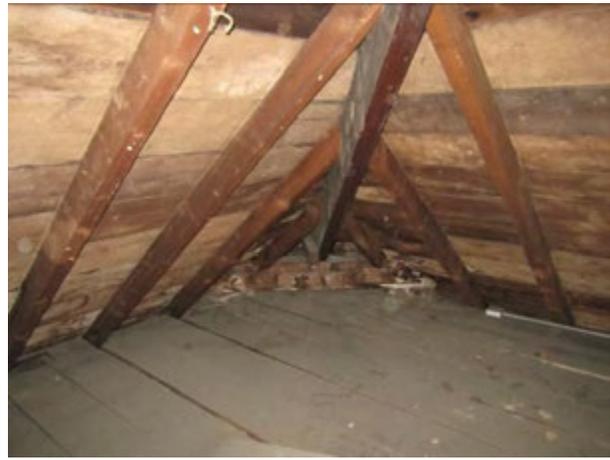
- a. The original roof framing, viewed from the attic access hatch, appears to be in generally good condition. Framing consists of 2x rafters, of various depths, at approximately 24 inches on-center. There were no visual signs of distress observed in the roof framing. See Photographs 1 and 2.

Photograph 1 – Attic framing

Photograph 2 – Attic framing

- a. The wood ceiling should be removed so that the roof framing along the gable walls and dormer can be observed. Based upon those observations, the gable end roof framing may need to be reconnected to the gable end walls.

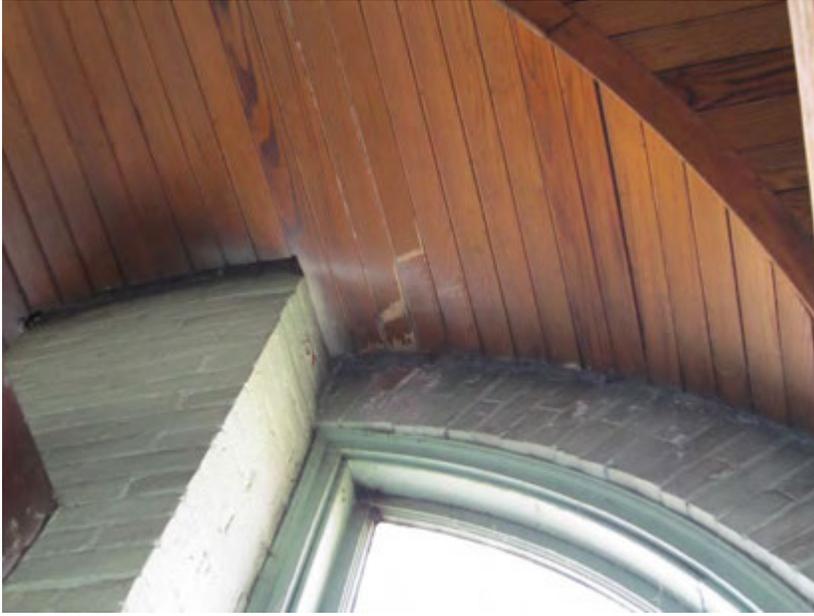
- b. Heavy timber trusses frame the roof of the gymnasium. The timber trusses are exposed to view and appear to be in good condition. The majority of the truss connections are visible from the running track. The connections are predominantly steel brackets and saddle plates with through-bolts. No sign of distress or damage was observed in any timber truss.
- c. A dormer exists on the east and west elevations of the buildings. A gap is present between the roof framing and the exterior wall that extends to the dormer. The wall was visually inspected from the ground and there does not appear to be any lateral displacement. See Photograph 3.

Photograph 3 – Gap at eyebrow dormer

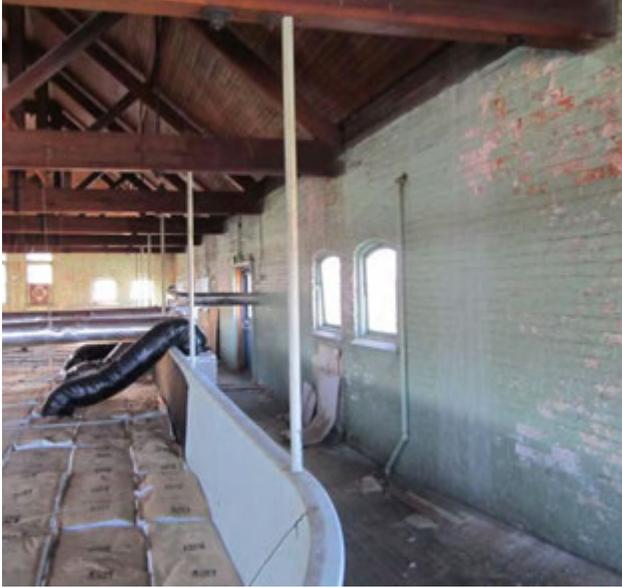
- a. The second floor framing was not visible in the south portion of the building.
- b. The running track is framed with 2x floor joists. The floor joists span from the exterior walls to built-up wood beams around the interior perimeter of the running track. In addition to being supported on the exterior wall, the interior perimeter of the running track is supported from the timber roof trusses with 1³/₄ inch diameter hanger rods. The hanger rod connection to the running track was not visible. See Photograph 4.
- c. The flooring of the running track is severely warped. See Photograph 5.

Photograph 4 – Running track hanger rod

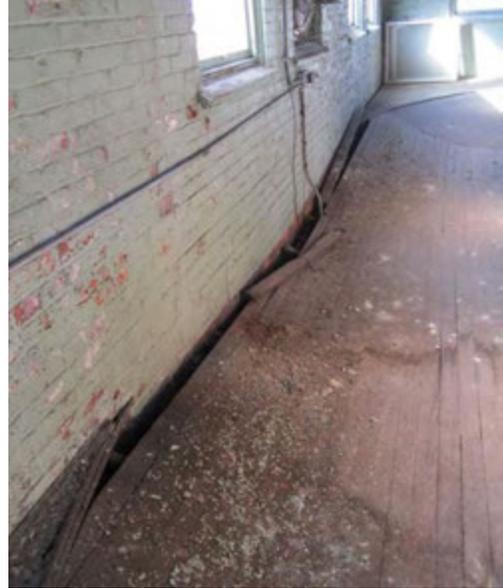
Photograph 5 – Damaged running track floor

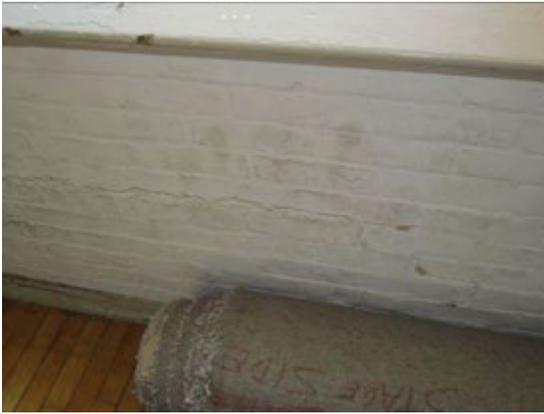
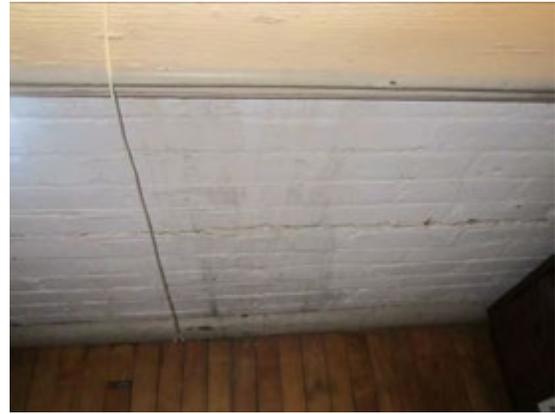
- a. The first floor framing was not visible in most of the building. A portion of the first floor framing was visible in the Mechanical Room. The framing that was observed consisted of 2x12 floor joists spaced at 12 inches on-center. Assuming that the entire first floor is framed with similar materials, the floor framing is adequate to support the loads required by code.
- b. Two horizontal cracks were observed in a mortar joint in the south exterior brick wall of the building. The first is located along the southwest wall of the original gymnasium, directly below two windows. The second crack occurs in the southeast corner of the building. Both cracks were observed from inside the building and have moved, horizontally, approximately $\frac{1}{2}$ inch. Neither crack nor any displacement was visible on the exterior of the building. See Photographs 6 and 7.

Photograph 6 – Southwest horizontal wall crack

Photograph 7 – Southeast horizontal wall crack

- a. The mortar surrounding the horizontal cracks in the walls should be removed and the wall should be re-pointed. Additionally, ¼ inch diameter helical ties should be installed in the displaced brick courses to prevent future movement in the wall.
- b. The 1x trim pieces that are displaced should be removed. Additional observations should be made to determine if a problem exists with the existing lintels.
- c. Several damaged window sills should be removed and rebuilt.
- d. A portion of the plaster should be removed in the southwest tower. Specifically, the window head should be exposed to determine if the cracks translate into the structural header above the window. If the cracking is present in the masonry wall, the wall will need to be re-pointed and reinforced with ¼ inch diameter helical ties.

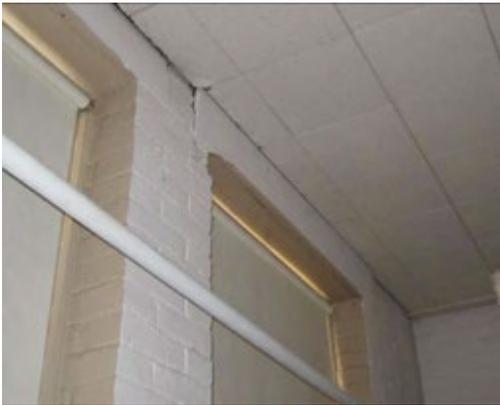
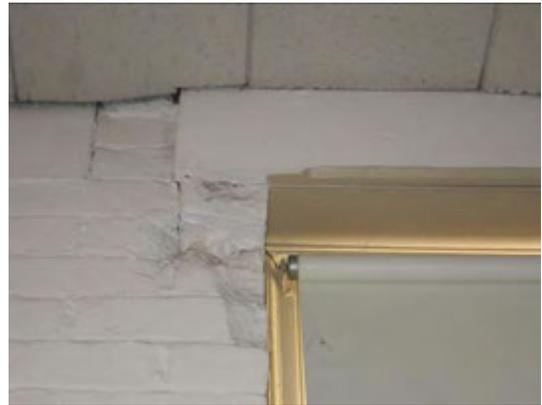
- c. It appears that the lintels above the first windows are trimmed with a 1x board. The majority of the 1x trim boards along the east and west walls of the building are displaced. Although the trim pieces are not structural, they may be concealing a possible water infiltration issue at the window heads. See Photographs 8 and 9.

Photograph 8 – Displaced 1x window trim

Photograph 9 – Displaced 1x window trim and brick damage

Brick and Stone base facades: The deteriorated window heads will require re-building. The cracks in the joints should be raked to remove any loose or deteriorated mortar and re-pointed with a matching mortar of the same/similar hardness mortar as the existing mortar. See the structural evaluation of this study for more information regarding this subject.

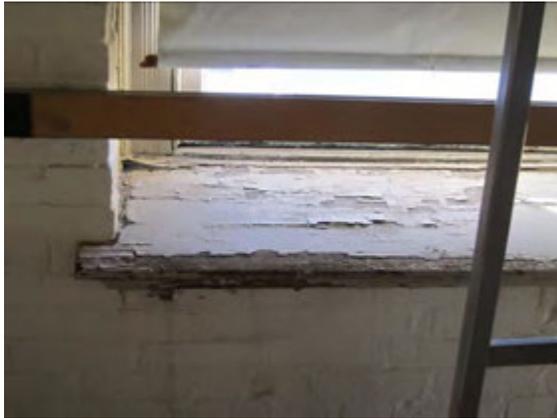
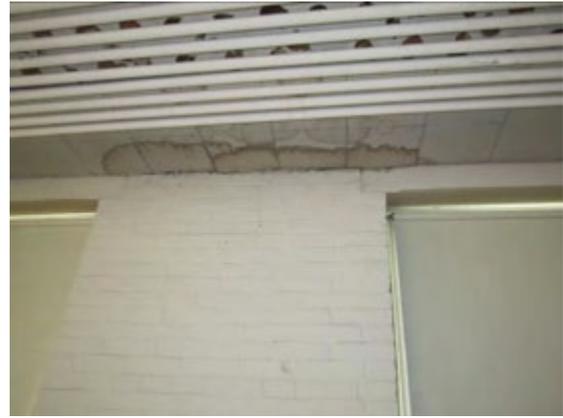
- d. The northwest corner of the first floor appears to be allowing water to infiltrate to the interior finishes of the building. Two window sills are rotted and should be replaced. Additionally, there are water stains on the ceiling tiles in multiple locations along the west wall. See Photographs 10 and 11.

Photograph 10 – Damaged window sill

Photograph 11 – Water stained ceiling tiles

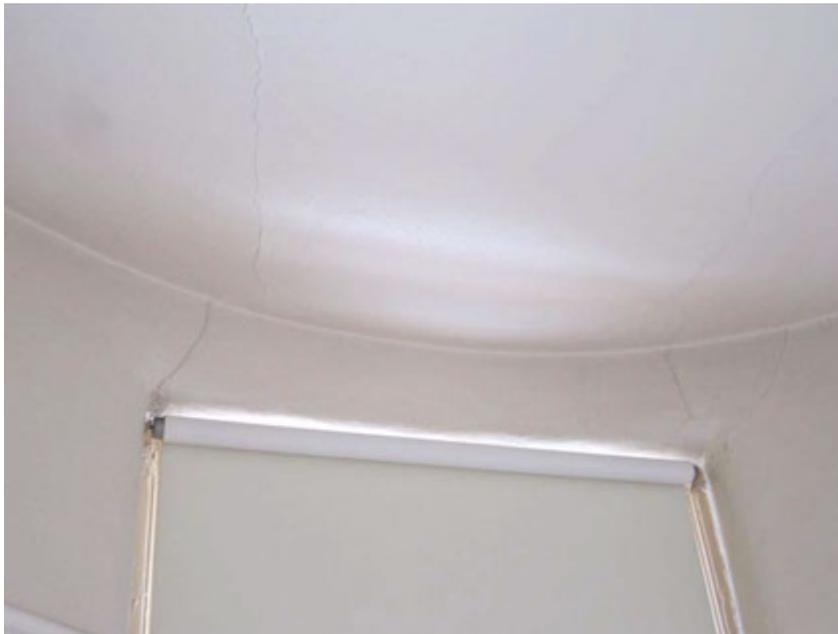
- e. The southwest tower is exhibiting a significant amount of cracking in the plaster finish. At the time of our site visit the tower was closed and it appears that this room is unused and unconditioned. The plaster cracks may be the result of temperature variations throughout the year. See Photograph 12.

Photograph 12 – Plaster cracks in south-west tower

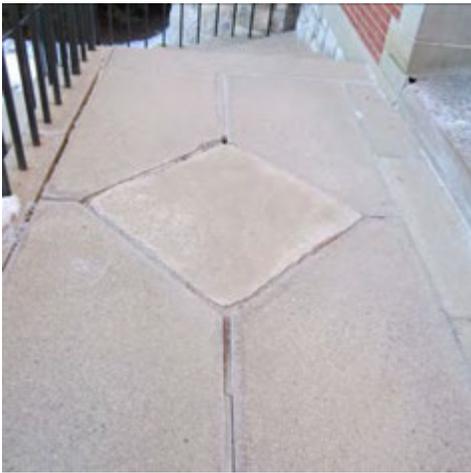
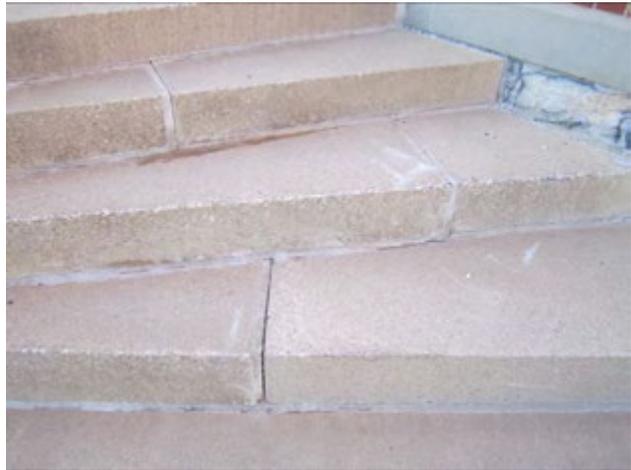
- a. The exterior walls are multi-wythe brick. Window lintels are flat, stone in the basement and first floor. Arched brick lintels were used on the second floor. The exterior of the building is in generally good condition. It appears that the exterior masonry was re-pointed in the past. No structural deficiencies were observed at the exterior of the building.
- b. The cast-stone stairs that serve the main entrance are beginning to separate at the joints. The horizontal and vertical joints between stair sections have deteriorated or are completely absent. Water can enter the open joints and cause further damage during freeze/thaw cycles. See Photographs 13 and 14.

Photograph 13 – Concrete landing

Photograph 14 – Concrete stairs

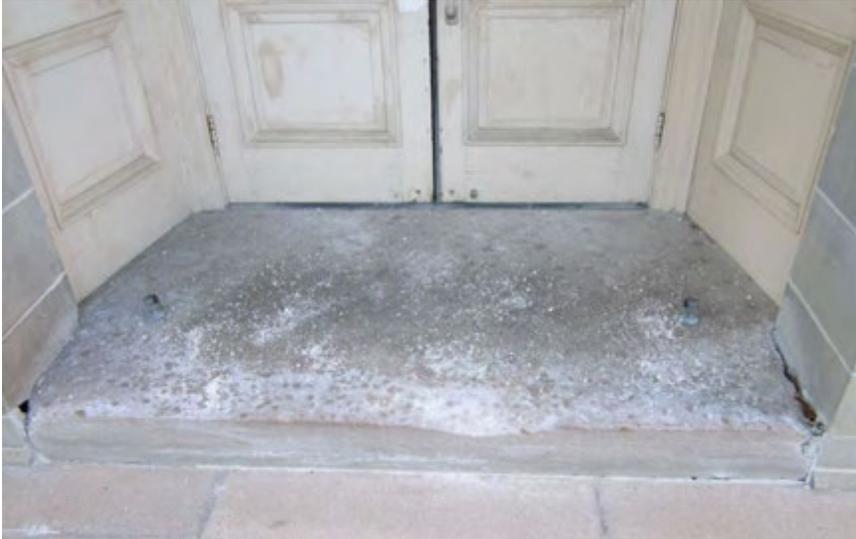
- c. The stone entrance slab in front of the main entrance doors is worn and pitted. Additionally, the joints along the east and west walls are significantly deteriorated. It appears that these joints are open to the walls and structure below, allowing water to infiltrate into the building. See Photograph 15.

Photograph 15 – Stone entrance slab

- b. The entrance stone slab should be cleaned. The joints along the east and west walls should be cleaned and resealed.
- c. The entire fire escape should be cleaned to remove any rust or loose paint (if not removed). The entire structure should be repainted.
- d. The stone lintel below the fire escape should be thoroughly cleaned. The lintel should then be evaluated to see if any section loss or significant cracking has occurred.
- e. The stone sill should be cleaned and all loose stone should be removed. In addition, the joint between the window and the sill should be sealed.

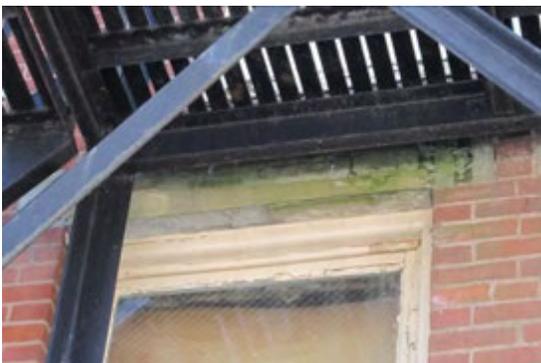
Photograph 16 – Discolored lintel

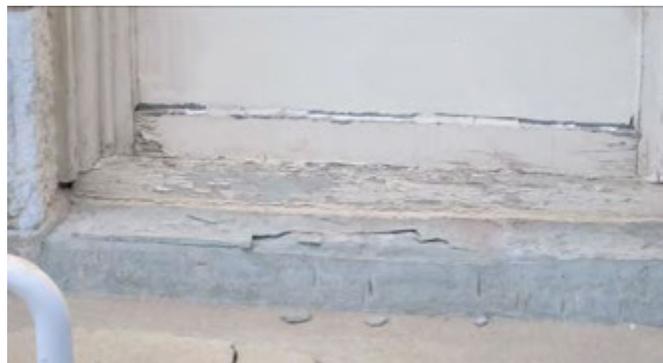
- d. The fire escape on the north elevation of the building is showing signs of age. The paint is deteriorated and missing over a large portion of the fire escape members.
- e. The deterioration of the fire escape has discolored and deteriorated the stone lintel over a window immediately below a fire escape platform. It appears that water has collected on the fire escape and infiltrated the stone lintel. See Photograph 16.
- f. A stone window sill on the west elevation adjacent to the ADA ramp is deteriorated. The stone has delaminated and is allowing water to infiltrate into the building. See Photograph 17.

Photograph 17 – Spalled stone sill

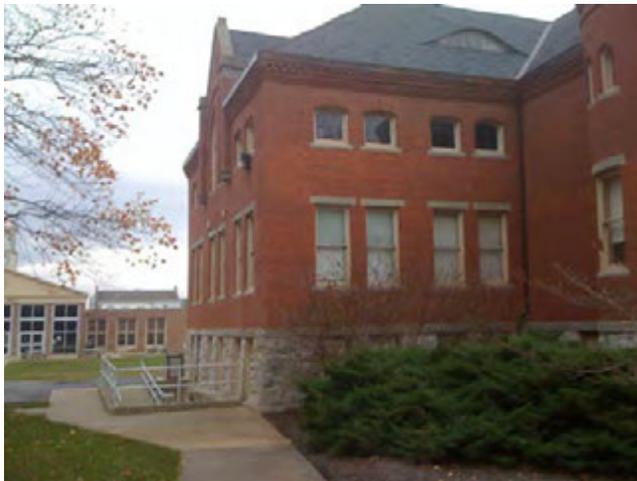
Southwest Corner

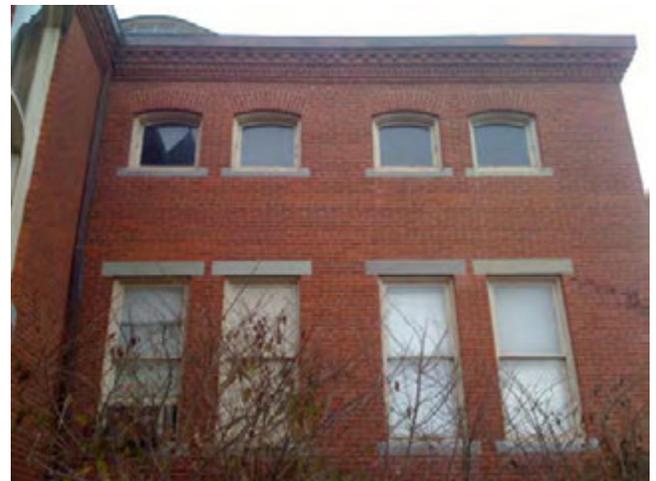
Southeast Corner - Windows

Windows: Energy efficiency and occupant comfort would benefit from replacing the windows with modern aluminum clad, wood windows of a similar type/ appearance acceptable to the Pennsylvania Historic and Museum Commission, to match the existing sizes, profiles, and details of the current windows.

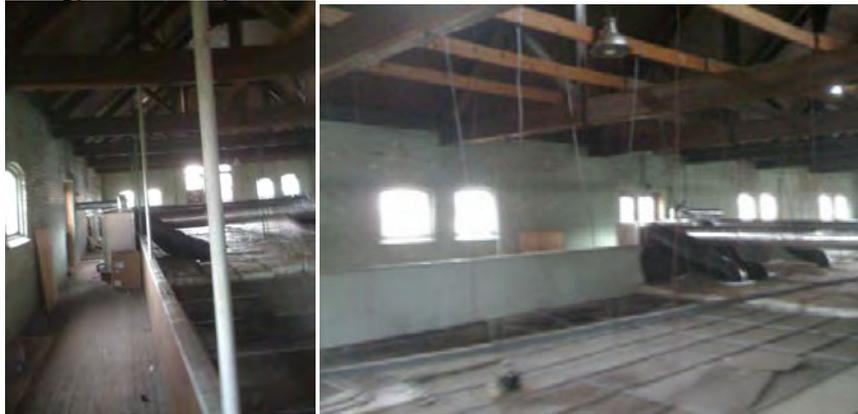
- a. Stewart Hall's mechanical systems are generally comprised of equipment that has been operated beyond the anticipated service life. Additionally, through meetings with university personnel and site observations, it has been determined that the current system would need to be removed and replaced with a new energy efficient system.

Existing Mechanical System

- e. An energy recovery ventilator will be utilized to provide tempered ventilation air through distribution ductwork to connect to each of the individual fan coil units. This unit will be located in the Lower Level mechanical room. Fresh air and relief air will be brought into/exchanged out of the building through two new louvers which will replace existing windows in this room.
