Rehabilitation of The Martin House

FEASIBILITY STUDY

October 2011

Shippensburg University
Shippensburg, PA

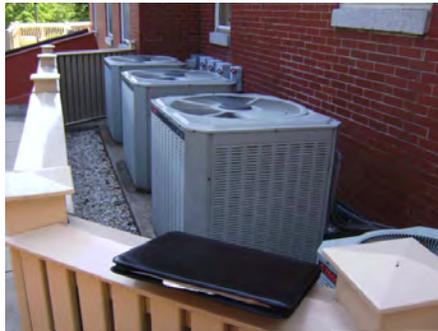
Existing Heat Pumps

The building is currently served by (4) split system heat pumps each consisting of an outdoor heat pump and indoor fan coil unit with associated distribution ductwork and air devices. Each indoor fan coil also has an associated electric/steam humidifier, which university maintenance personnel have disabled. While the heat pumps were Energy Star rated at the time they were installed, at 12 SEER they do not meet the current minimum requirement of 13 SEER for this type of equipment. Additionally, at 15 years old, this equipment is approaching the end of its anticipated service life. Based on conversations with the university personnel, at least three of the units (one serving the third floor guest suite, one serving the majority of the second floor bedrooms and one serving the kitchen) have difficulty maintaining desired space conditions. A window air conditioning unit has been installed in the third floor guest suite to supplement the existing system.

- a. Replace the existing 12 SEER split system heat pumps as they are nearing the end of their service life. Replacement units would be 15 SEER to reduce operating costs by using less energy. The units serving the 3rd floor guest suite, the majority of the 2nd floor bedrooms and the kitchen should be evaluated to determine if the available capacity is adequate and the size of the replacement units should be adjusted accordingly. The replacement units shall be relocated to a more appropriate, out-of-sight location indicated on the architectural drawings attached to this report.

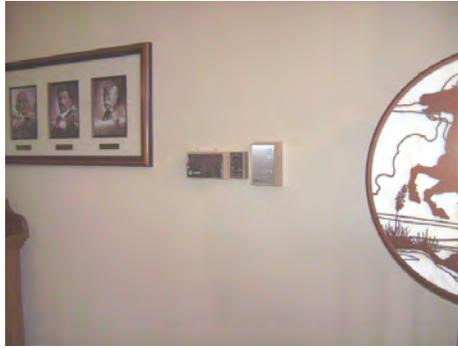
Existing Control Devices

While the university has a campus-wide energy management system this building, with the exception of the central plant and perimeter baseboard heat, has not been integrated into the campus system. The split system heat pumps and energy recovery ventilator operate on standalone controls. This prohibits the facilities maintenance department from receiving any alarm conditions indicating problems with the equipment, or from obtaining trending data which could be used to analyze system performance and make operating changes to increase system efficiency.

The existing perimeter baseboard heating loop is served by a single temperature sensor located in the living room. This leads to poor control of this system as individual spaces may be over- or under- heated depending on what the living room sensor is reading and actual load conditions for the space.

- a. Integrate the building systems with the campus wide energy management system by Automatic Logic. This will allow for the provision of alarm conditions to notify the facilities maintenance personnel of equipment failures as well as for trending information to better analyze and modify building operation for improved energy efficiency.

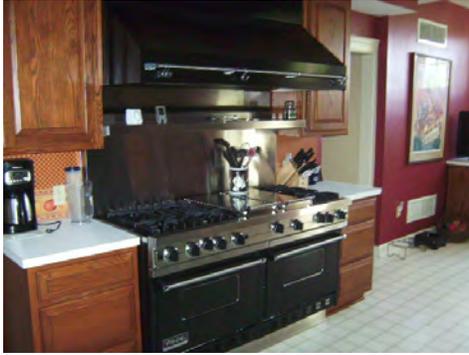
Existing Kitchen Hood

The kitchen range is served by a commercial-style range hood. This hood exhausts a significant amount of air with no makeup air source present. Currently it is believed that the hood is drawing makeup air in thru the existing windows. However, with new windows being proposed as part of the renovation, this makeup air path will be cut off. All three university groups with which we met indicated that the space does not maintain temperature when the hood is in operation. Lack of sufficient make up air for the hood is a major factor in the inability to maintain desired space temperature.

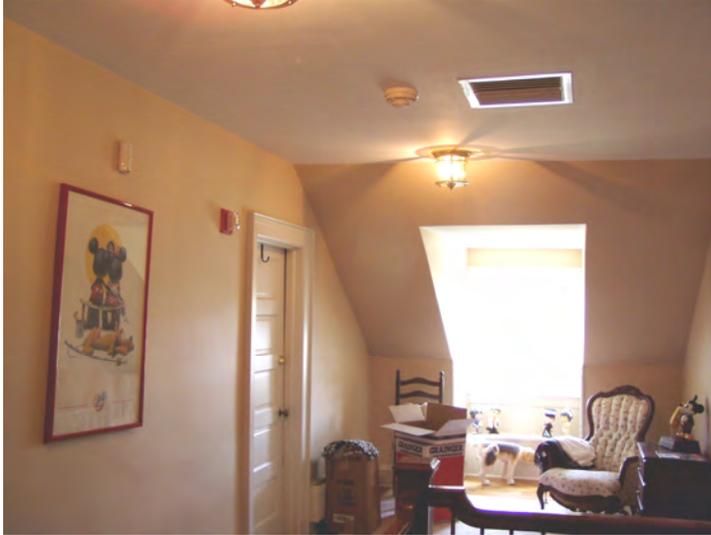
The main fire alarm control panel is a Cerberus Pyrotronics model SXL and is located in the basement. The fire alarm appears to be a non-addressable system installed in approximately 2000, while it meets current codes, University standards require an addressable system to be installed. This fire alarm system is a 4/8 zone conventional wiring type system. A small remote annunciator with LED indicator lights is installed near the kitchen vestibule door. The building is protected throughout by automatic detectors such as smoke detectors in most rooms and heat detectors in mechanical and kitchens areas. Audible/visual (horn/strobe) devices are provided on each level typically in the stair hall. The system is monitored by Shippensburg University Police.

Fire Alarm AV Device and smoke detector. Security motion sensor.

3. Fire Alarm System
- a. Replace the existing Fire Alarm control panel with an addressable system that will network with the campus system and meets the University Design Guidelines. System shall be compatible with existing conventional devices such that the existing interior building wiring and initiation devices (smoke detectors, heat detector, etc.) would not need to be replaced.

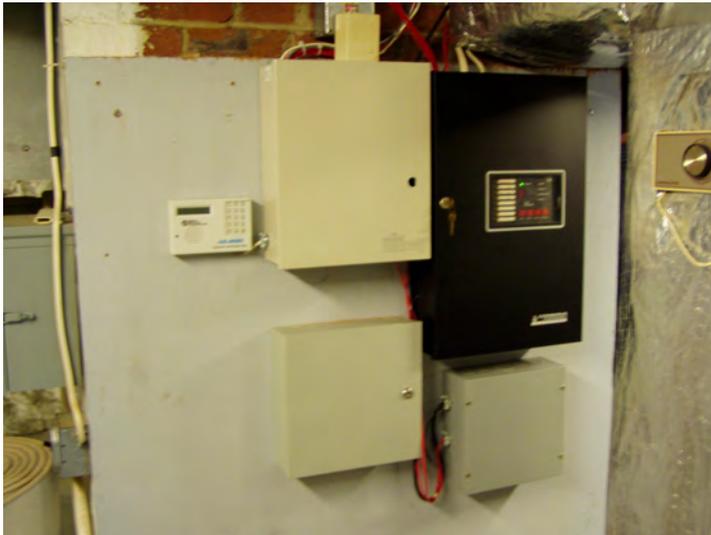
The building is also protected by a Maxsys hard wired security system. The system appears to be from the 1995 renovation and is inadequate to meet current needs. The main control panel is located in the basement adjacent to the Fire Alarm control panel. A remote keypad is installed near the Kitchen vestibule door and also at the second floor landing. PIR type motion detectors are installed throughout the building for security coverage and alarm initiation. Door switches were evident at the first floor entry doors. It is possible that some devices are wireless RF type.

Security and Fire Alarm control Panels

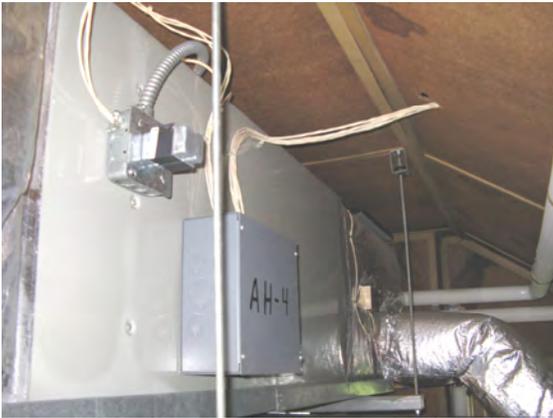
- b. New mechanical equipment was added in 1995. An air handler appears to be suspended from third floor ceiling joists. We do not know if existing framing was reinforced to support this equipment. See Photograph 3.

Photograph 3 – Air handler suspended from attic or roof framing.

- a. The split roof framing member should be sistered with a new 2x8.
- b. The concentrated loads on the third floor should be spread out, or the floor framing reinforced for light-storage loading.
- c. New mechanical equipment was added in 1995. An air handler appears to be suspended from third floor ceiling joists. No signs of structural distress are evident. See Photograph 3.
- d. Reinforce the Guest Room floor framing to level the floor and provide increased load capacity.
- e. Re-frame the third floor stair header and stringers to remove the uncomfortable and hazardous slant.

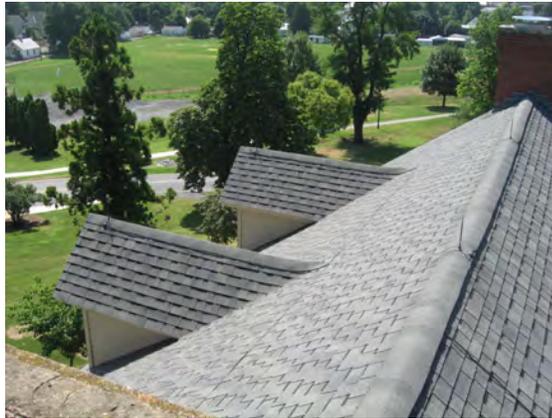
Roof & Gutters: This roof system should be replaced with a new asphalt fiberglass system with proper underlayment and ice and water shield, and historically accurate zinc/ lead coated copper valley and other flashings as/ where required. The size, location and routing of the gutter system need to be corrected as part of the re-roofing work and any proposed alterations/ additions undertaken.

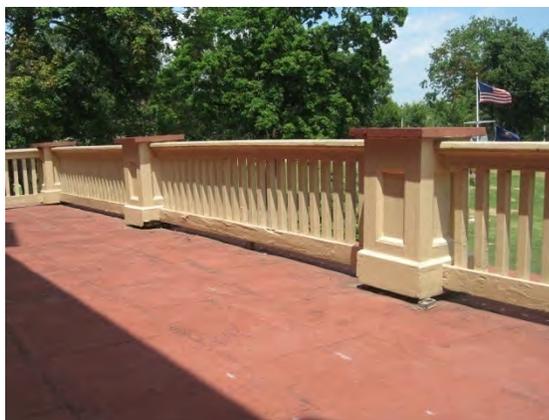
Second Floor Deck and Railing

Miscellaneous exterior wood trim/porches: The railing and other trim pieces must be patched and repaired and in many instances, new matching high quality wood painted components must be fabricated and installed by skilled craftsmen/ carpenters experienced in this type of work.
