FACILITY STUDY • SU 2004/17
Facilities Detailed Project Planning Document

HUBER ARTS CENTER
**SHIPPENSBURG
UNIVERSITY**

SHIPPENSBURG CUMBERLAND COUNTY PENNSYLVANIA
Architect's Project No. PP5929

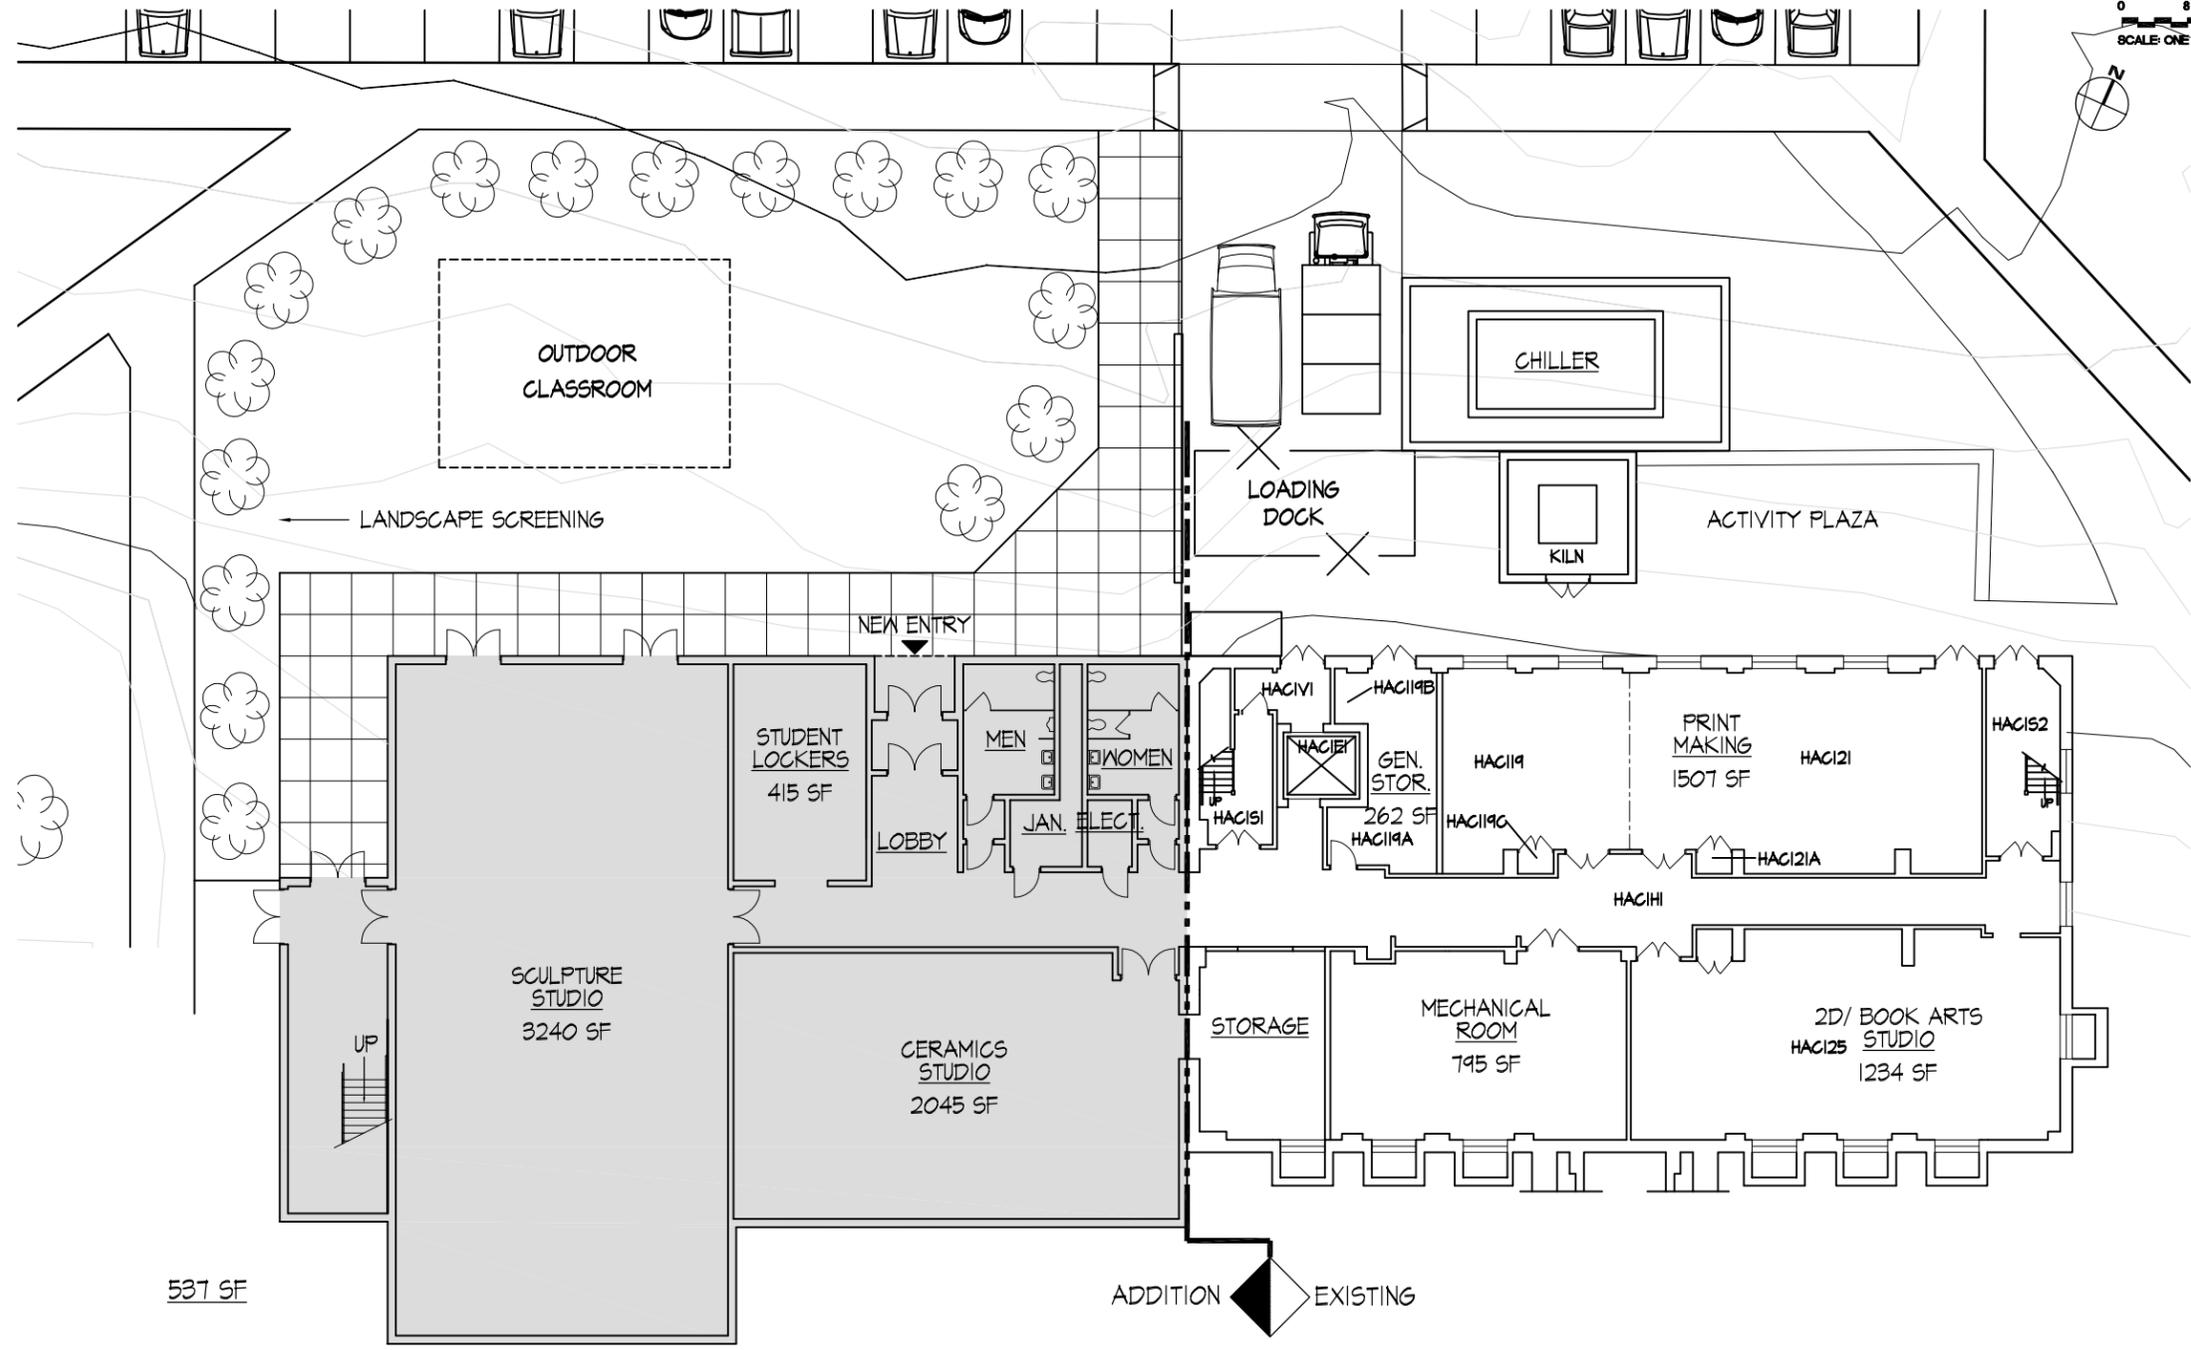
PROPOSED GROUND FLOOR PLAN
SCHEME A

7218 GSF ADDITION
