*The Relationship Between the Inside and Outside Environments of the
Shippensburg University Rife Alumni House: A Comprehensive Energy Analysis*

Michael D. Griesemer

GEO 549

Shippensburg University

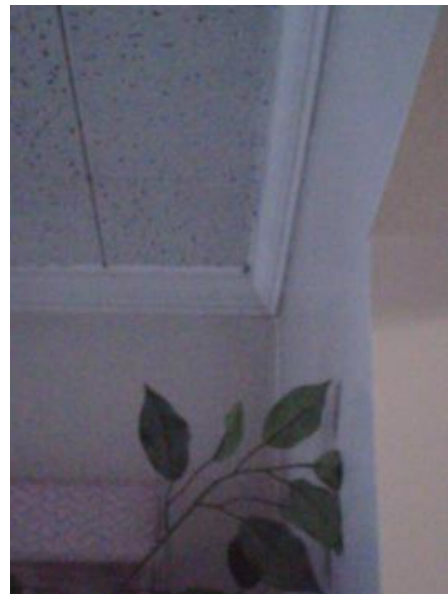
First Floor Front Elevation Wall
12/9/2013 5:31:44 PM

Top plate air movement.

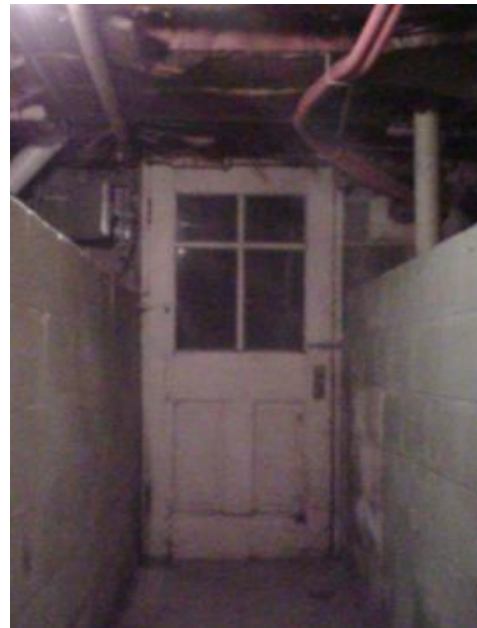
Rear Elevation Basement Door

Lack of air sealing.

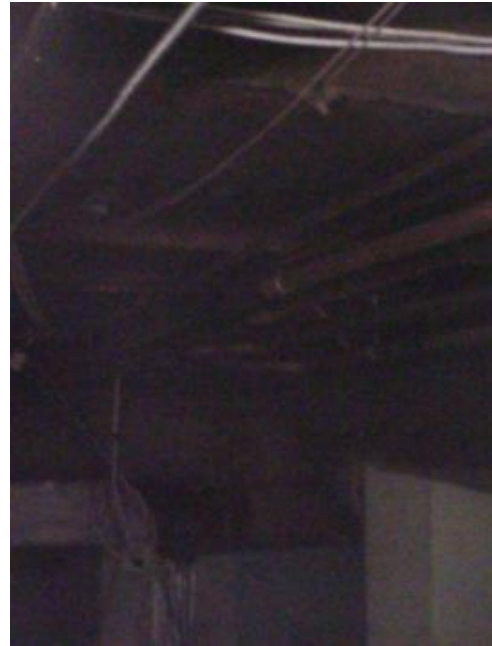
Basement Ceiling – Water Pipes
12/9/2013 5:44:05 PM

Lack of insulation

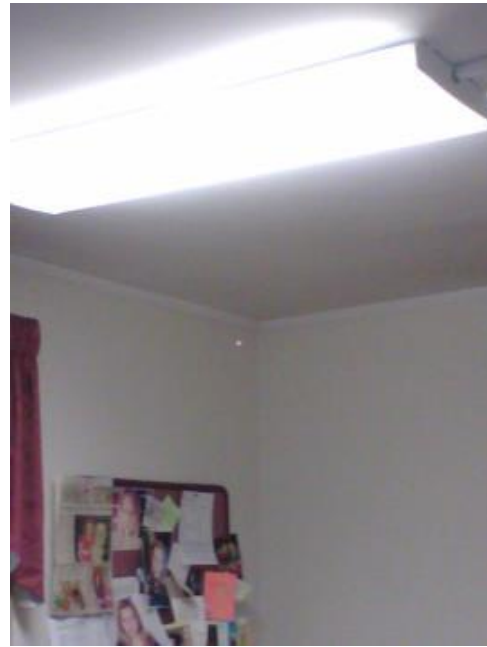
Second Floor Front Elevation
12/9/2013 5:46:08 PM

Air movement through wall seam.

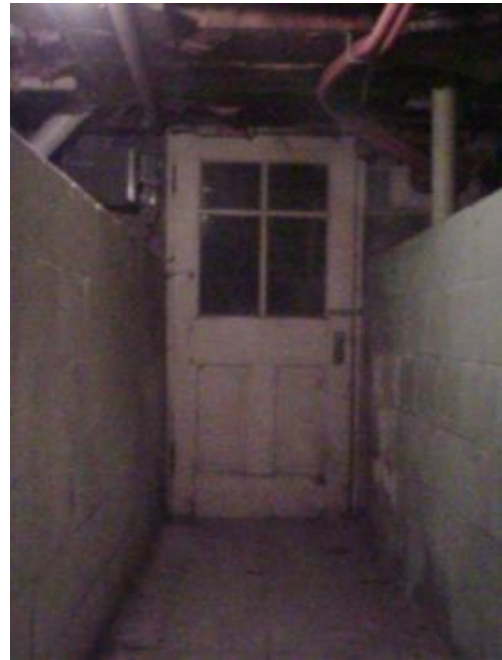
Rear Elevation Basement Door
12/9/2013 6:39:14 PM

Lack of air sealing.

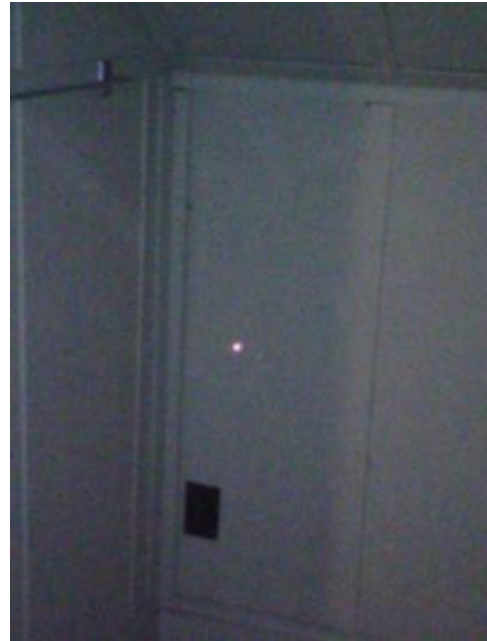
Third Floor Attic Side Wall Panel
12/9/2013 6:55:07 PM
Lack of air sealing and insulation.

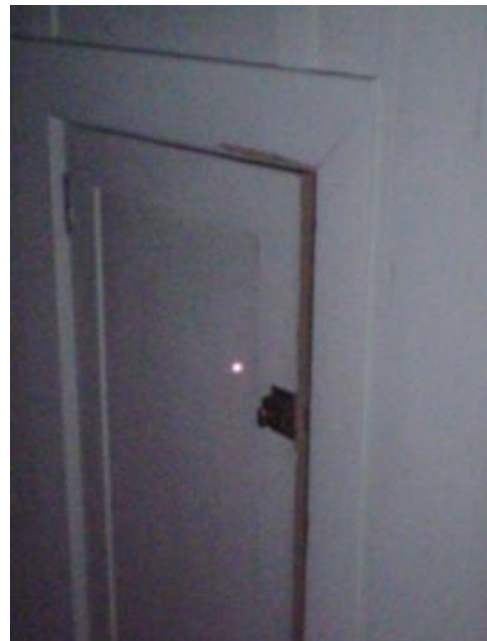
Third Floor Attic Kneewall Access
12/9/2013 6:55:42 PM
Lack of air sealing and insulation.
